# **A GIS- BASED WATERSHED MANAGEMENT PLAN FOR THE PITI-ASAN WATERSHEDS**

**Technical Report No. 139**

**October 2012**

*This project is funded by the National Oceanic and Atmospheric Administration  
through the Guam Coastal Management Program, Bureau of Planning,  
Government of Guam Project no. CRI-GU-10.*

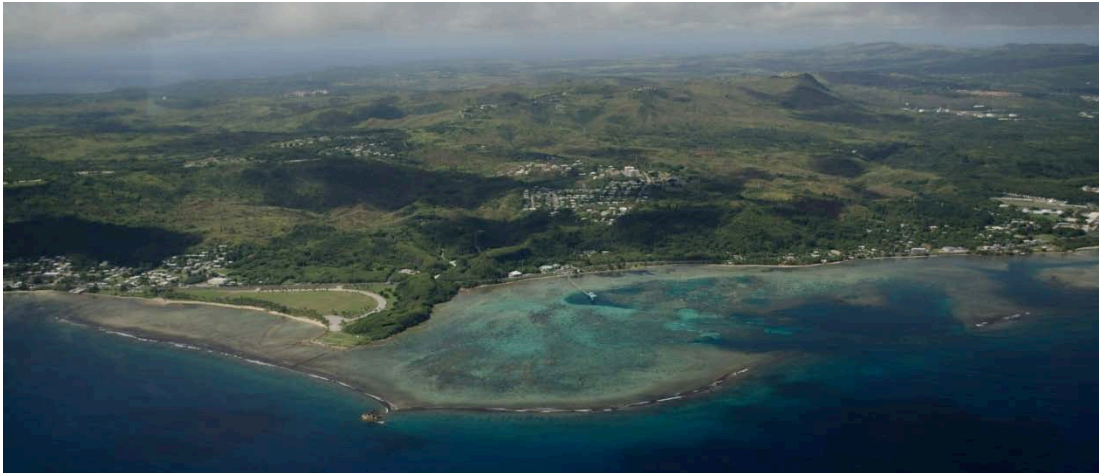
Figure 1: Piti-Asan Watershed (2012)

The Piti-Asan Watershed is located along the western shore of central Guam (Figure 1). The boundary of the watershed, outlined in Figure 2, ranges from Adelup to the Piti Power Plant and inland to the ridgeline on Nimitz Hill with Sasa Valley Tank Farm to the South and encompasses only part of Piti and Asan Municipalities. According to a recent study by Kottermair (2012), the Piti-Asan Watershed is one of three "priority watersheds needing restoration in the Clean Water Action Plan."

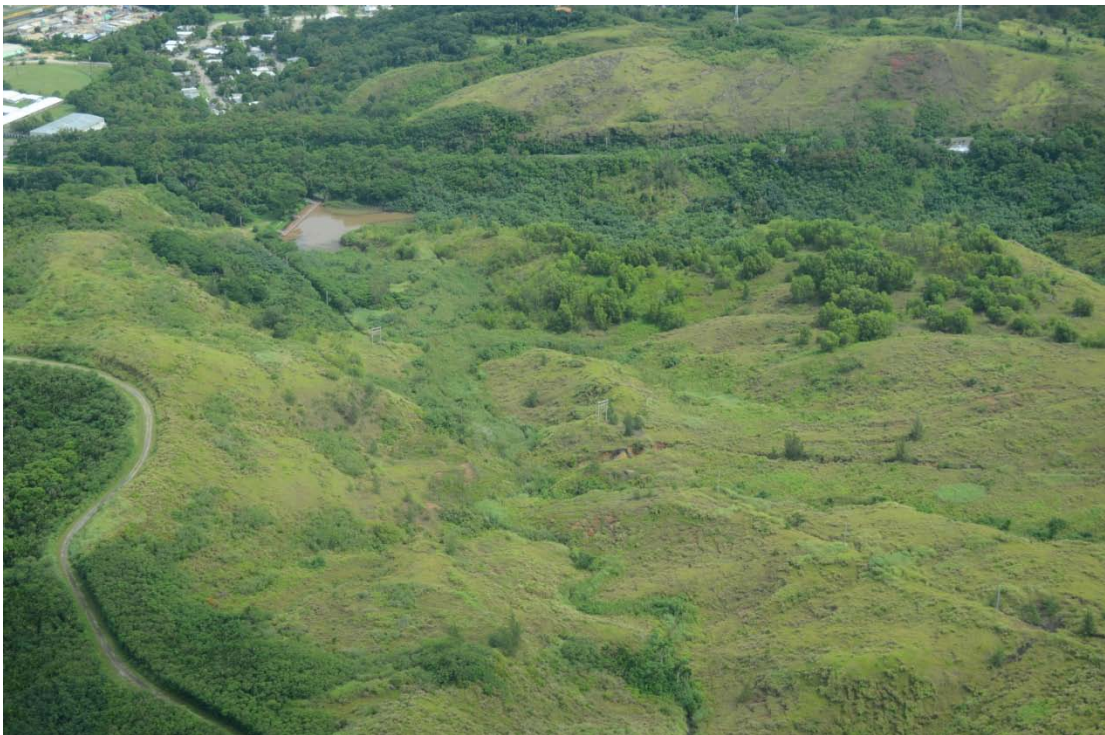
Figure 7: Masso Reservoir, Piti (August 16, 2012)

According to Wiles and Ritter (1993), the Masso Reservoir in Piti (Figure 7) is a man-made reservoir that is a common moorhen habitat. The reservoir was built by Navy around 1945 for drinking water use but abandoned due to siltation in 1951. Since then, the property was turned over to the Government of Guam. The Guam Department of Agriculture's Division of Aquatic and Wildlife Resources (DAWR) renovated in 1978 as a fishing area but the project was terminated in 1983 due to illegal fishing with chlorine (Wiles and Ritter, 1993). Most recently, DAWR has renovated the reservoir for recreational use including a fishing platform. The renovation project also included reforestation efforts and hiking trails surrounding the Masso Reservoir (Figure 7).

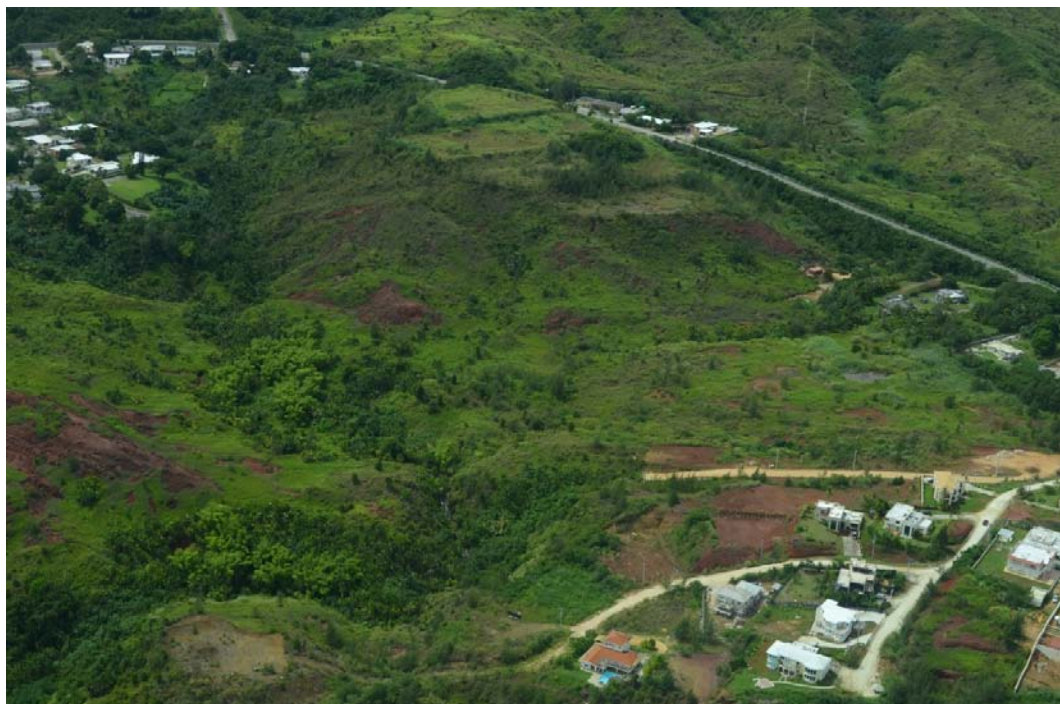
Figure 9: Site of Proposed JHP Development (August 16, 2012)

One such planned development is a proposed 240 unit residential subdivision on a 25 acre lot on Nimitz Hill by JHP Development (Figure 8 and 9), which was rezoned from agricultural land (zone A) to a multi-family residential zone (R-2). This proposed development poses a risk of increased sedimentation due to proximity to the nearby Asan River and stream, which passes through the property as well as its uneven and partly steep sloping terrain (Kottermair, 2012). Other individual houses and business infrastructure are also expected in the area because of the increasing island population.

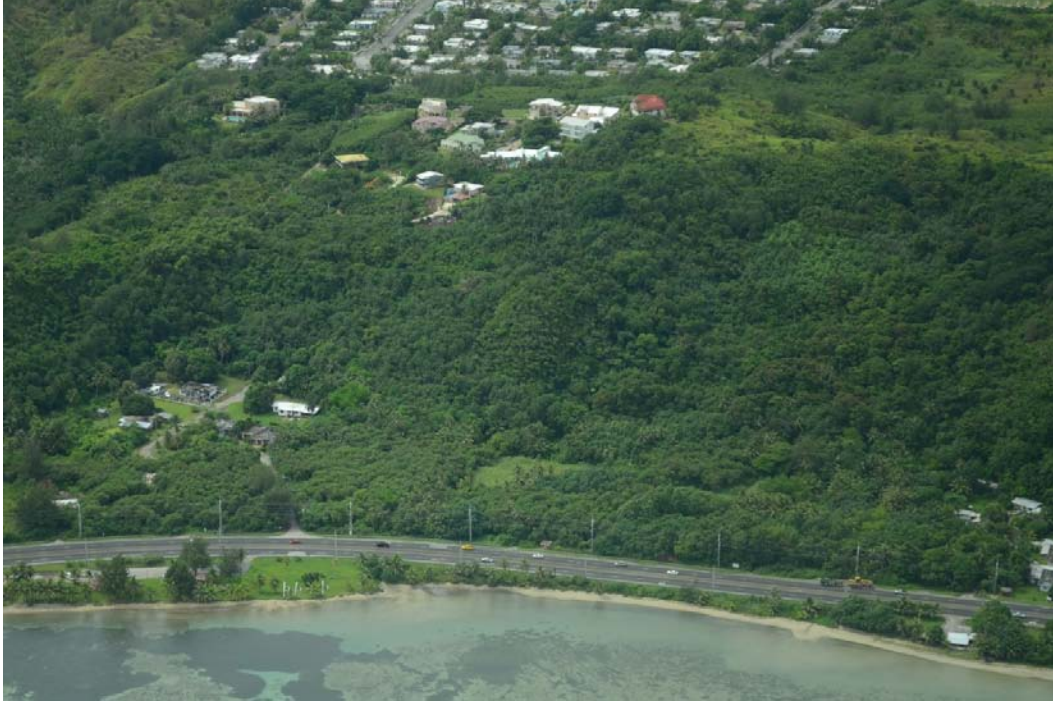
Figure 10: Site of Proposed Hanjin Development (August 16, 2012)

A second large scale planned development of 194 residential units comprised of 78 single-family homes and 116 condominium and townhouse units by Hanjin Heavy Industries & Construction Co., Ltd (DC&A, 2011). About 33 acres of land is undergoing a proposed zone change from agricultural zone (A) to a multifamily-residential zone (R-2). The proposed project site is located in Piti (Figure 8 and 10) and is adjacent to the Nimitz Estates subdivision on Nimitz Hill (DC&A, 2011). In addition to the major proposed developments by JHP Development and Hanjin Heavy Industries & Construction Co., Ltd other private homes are also being constructed within the Piti-Asan Watershed (Figure 11, 12, 13, and 14).

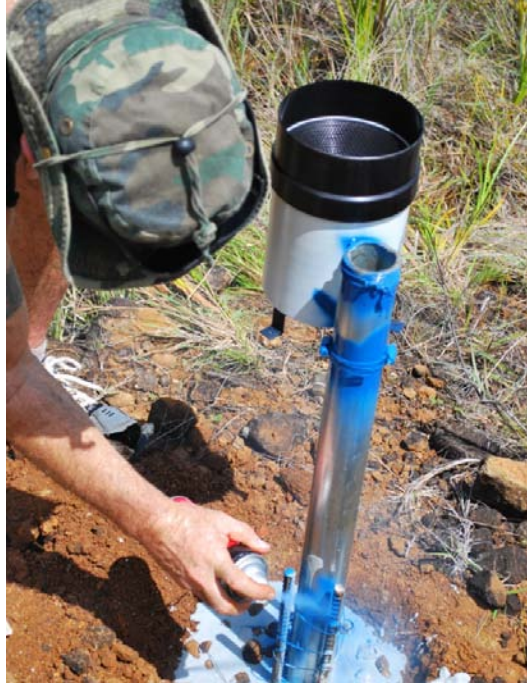
Figure 16: Installation of the Asan Rain Gauge (June 9, 2011)

Rainfall was measured using two tipping bucket HoboWare® data logging rain gauges (Figure 16). The rain gauges were placed at two randomly selected sites around the Piti-Asan watershed. Site selection criteria included areas which were unobstructed by large vegetation, buildings, or any other large obstructions that could block rainfall to the rain gauges. Rain gauge sites were also chosen based on ease of access to the site and the risk of damage to the rain gauge by human activity.

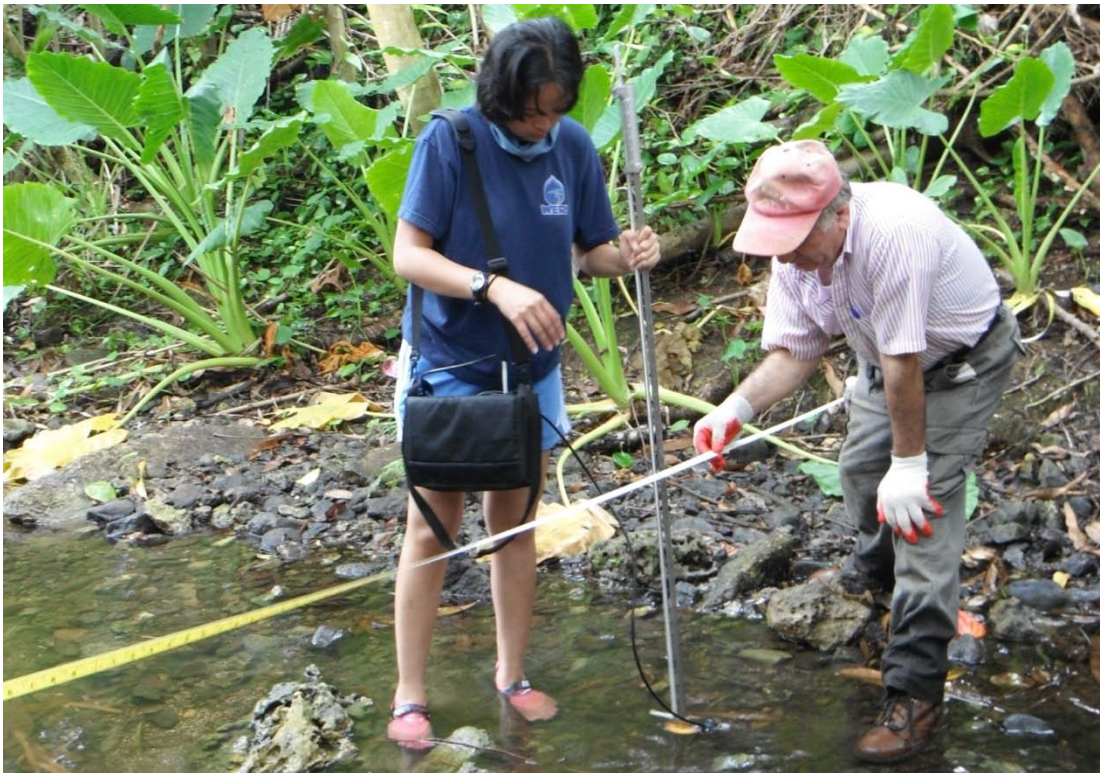
Figure 17: Stream Flow Measurement in Masso River (March 12, 2012)

Flow was measured weekly in the Masso and Asan Rivers using an electronic flow meter (Figure 17). Flow measurements were taken along transects running perpendicular to the flow direction at 0.5 foot increments from edge to edge of the river. Flow rate calculations included distance from the edge of the river, depth, and velocity as well as indications of the edge positions. The data was later input into a spreadsheet program, which calculated the flow output of the river based on the area and velocity measured at each increment.

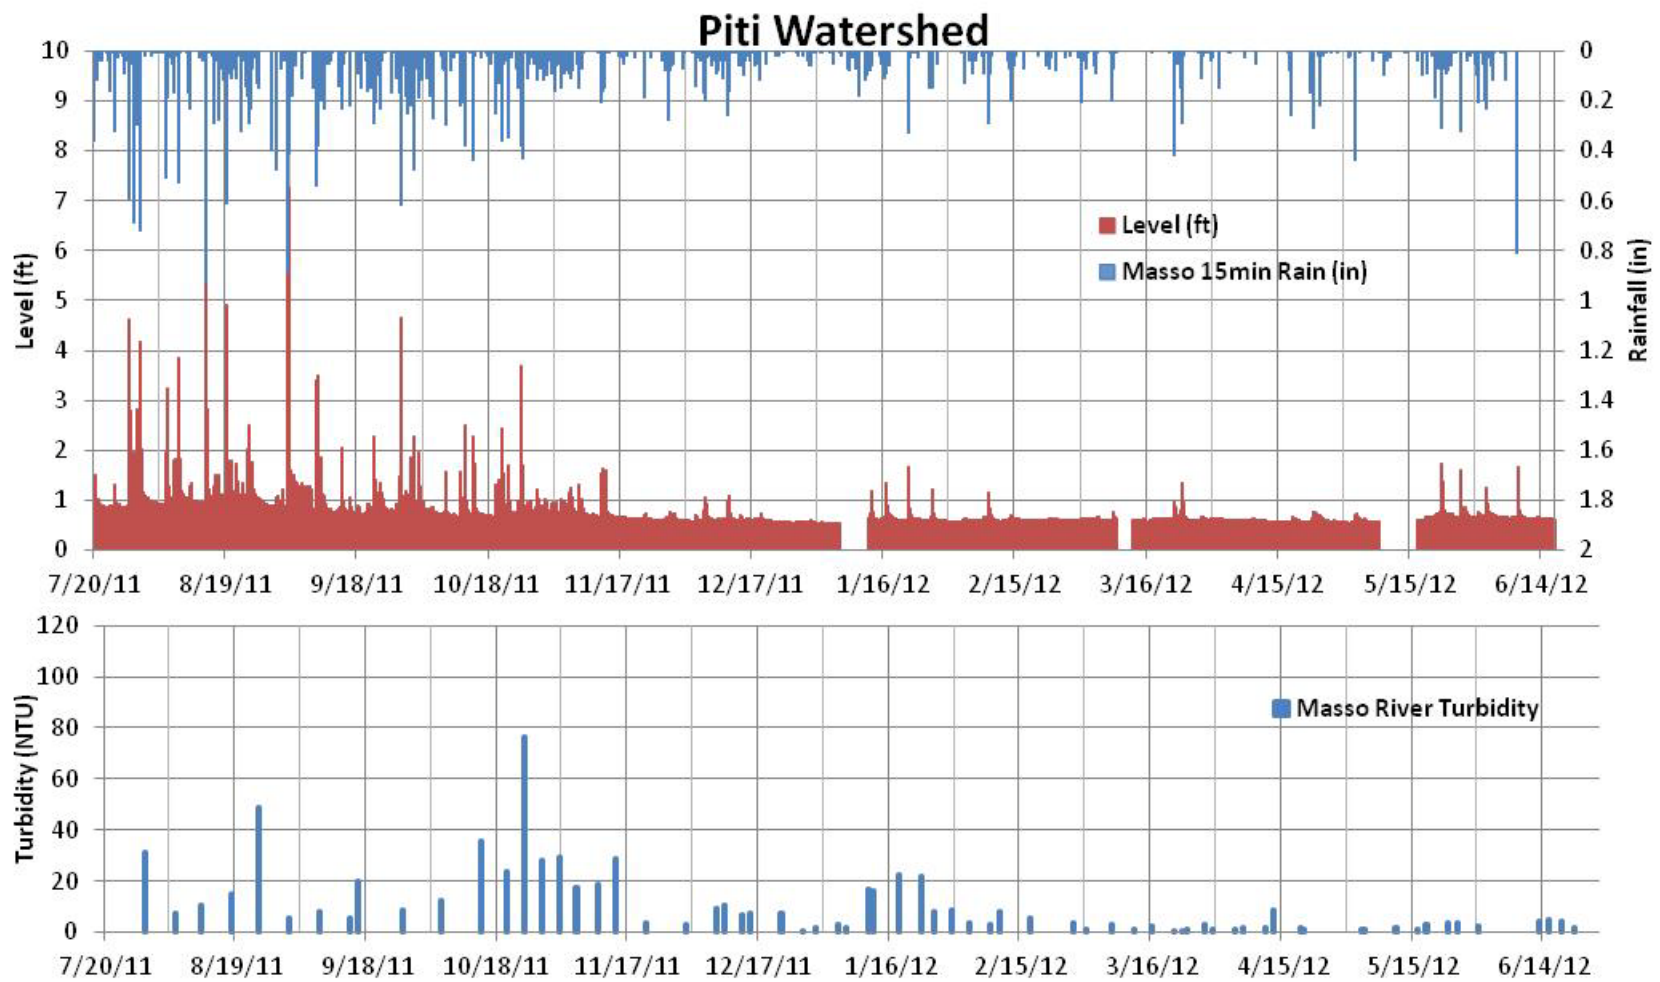
Figure 21: 15-minute Rainfall, River Level, and Flow to the Masso River

The hydrologic data gathered in the course of the study from the Masso and Asan Rivers are shown in Figure 21 and 22 respectively. These included the rainfall collected for each watershed, stream level measured at 15 minute intervals, and the biweekly turbidity measurements. Figure 23 and 24 show the 15 minute rain and stream levels of the rivers during a single storm event. These figures are able to more clearly display the reaction time of water level to changes in rainfall.

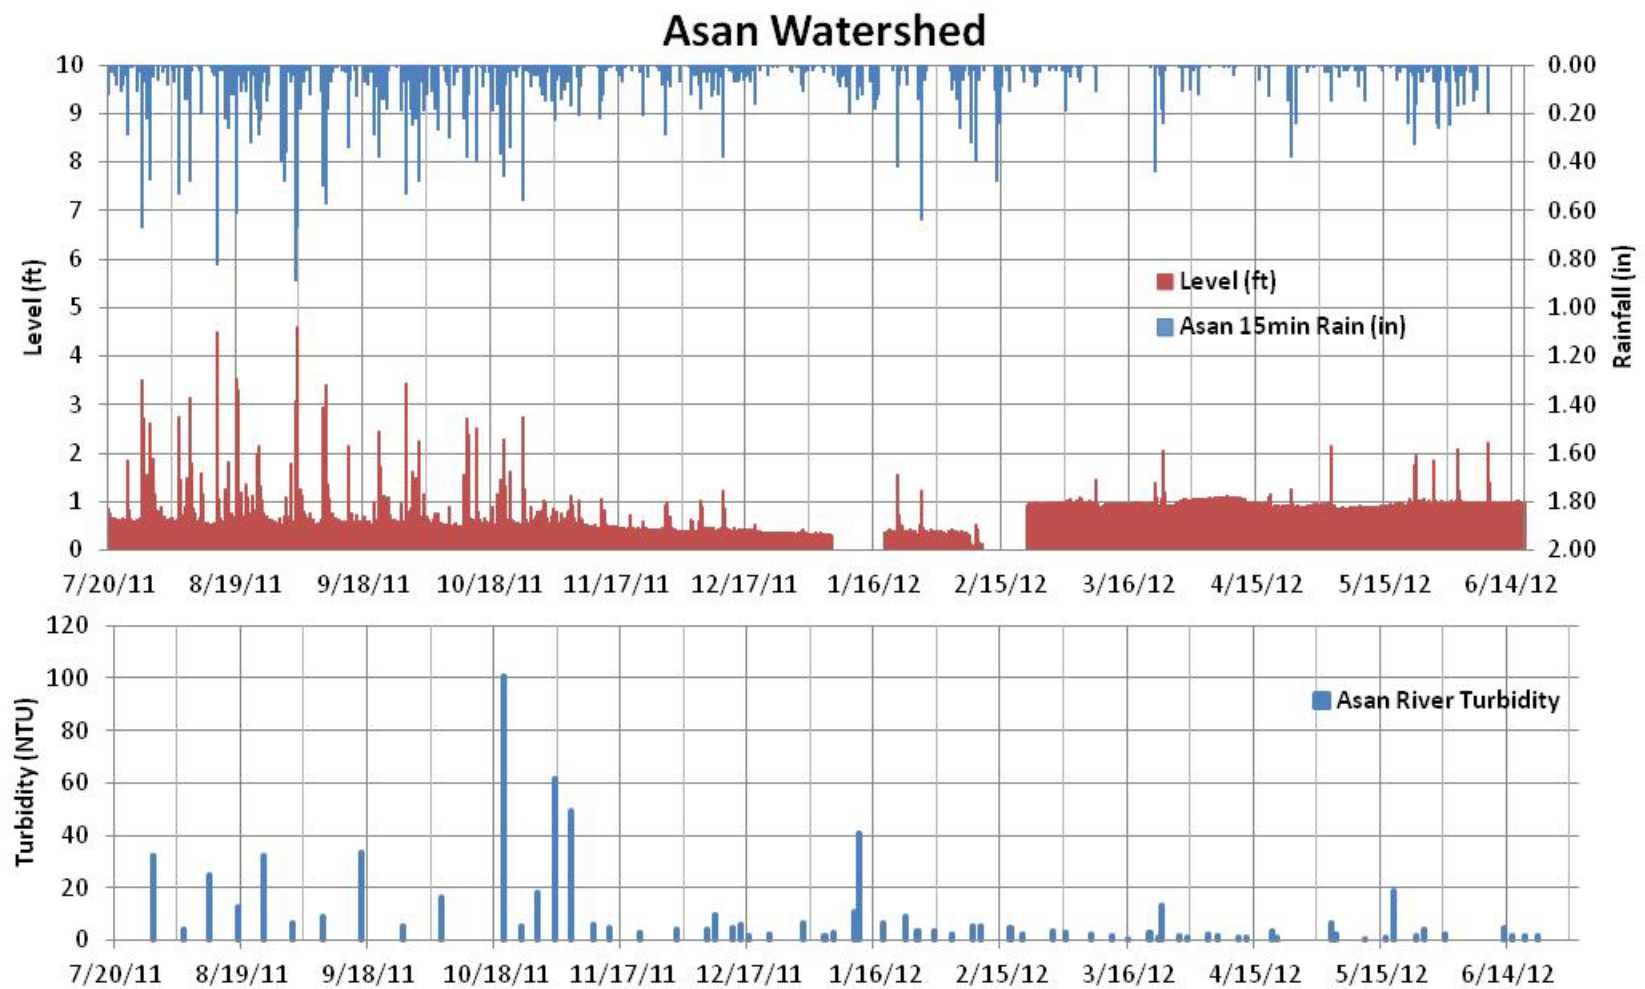
Figure 22: 15-minute Rainfall, River Level, and Flow to the Asan River

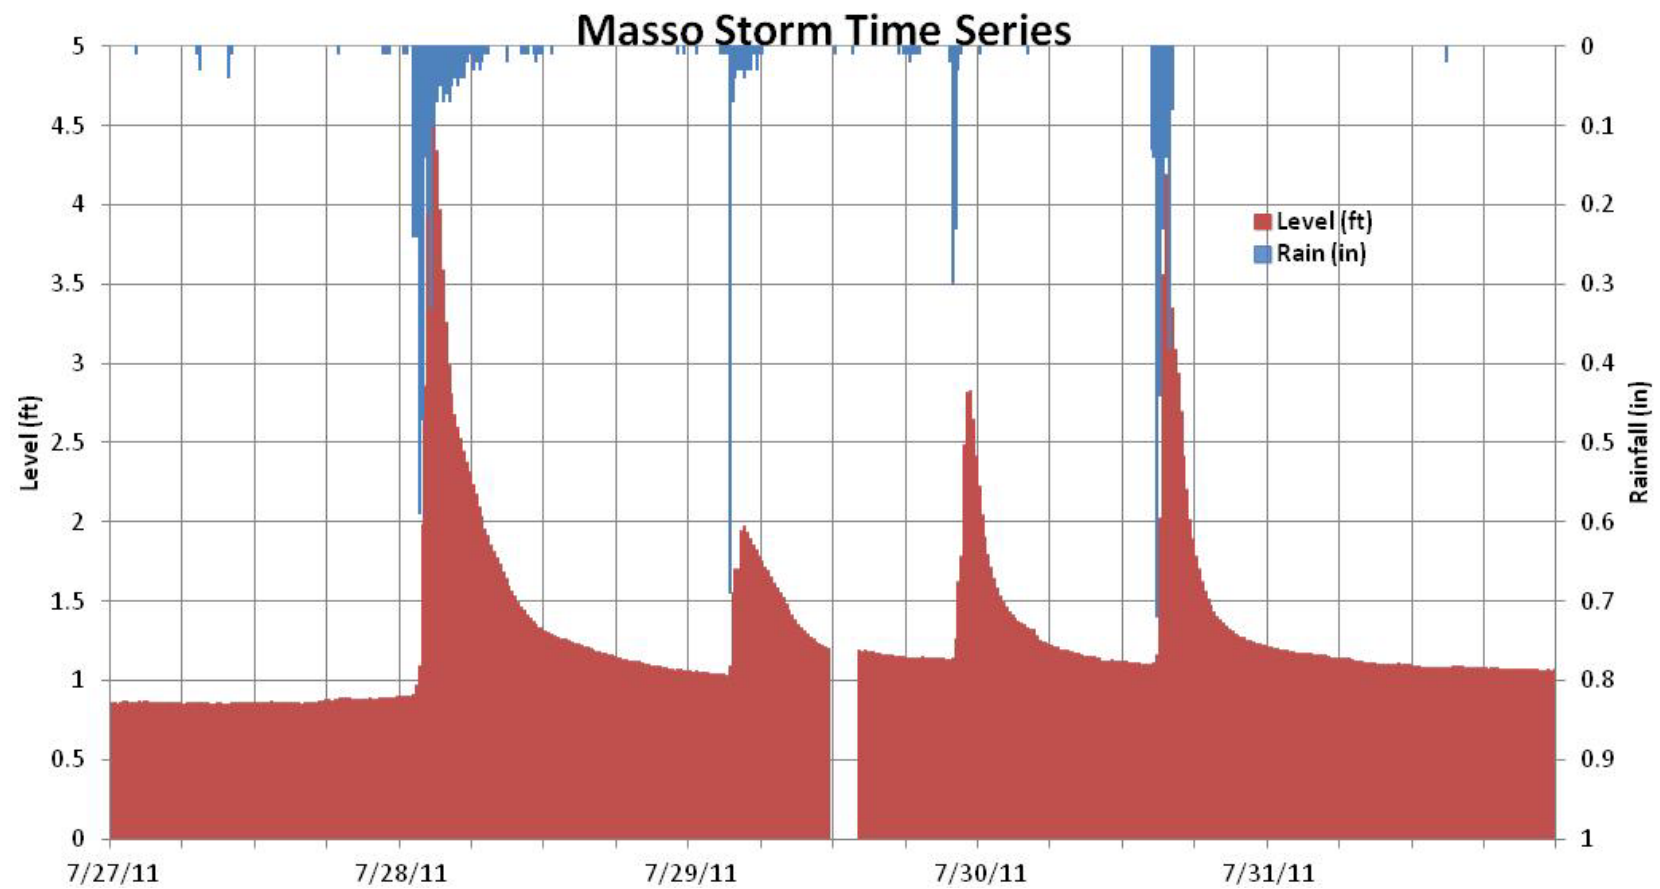
Figure 23: Masso Storm Event

As observed by Figure 23, the reaction time of the Masso River's peak water level from peak during storm events was shown to have occurred within 45 minutes of the peak rainfall during large rainfall events when compared at 15 minute intervals. The Asan River's reaction time was shown in Figure 24 to have occurred within 30 minutes of peak rainfall during major storm events. This indicates that the water level of the Asan River is more reactive to rainfall events.

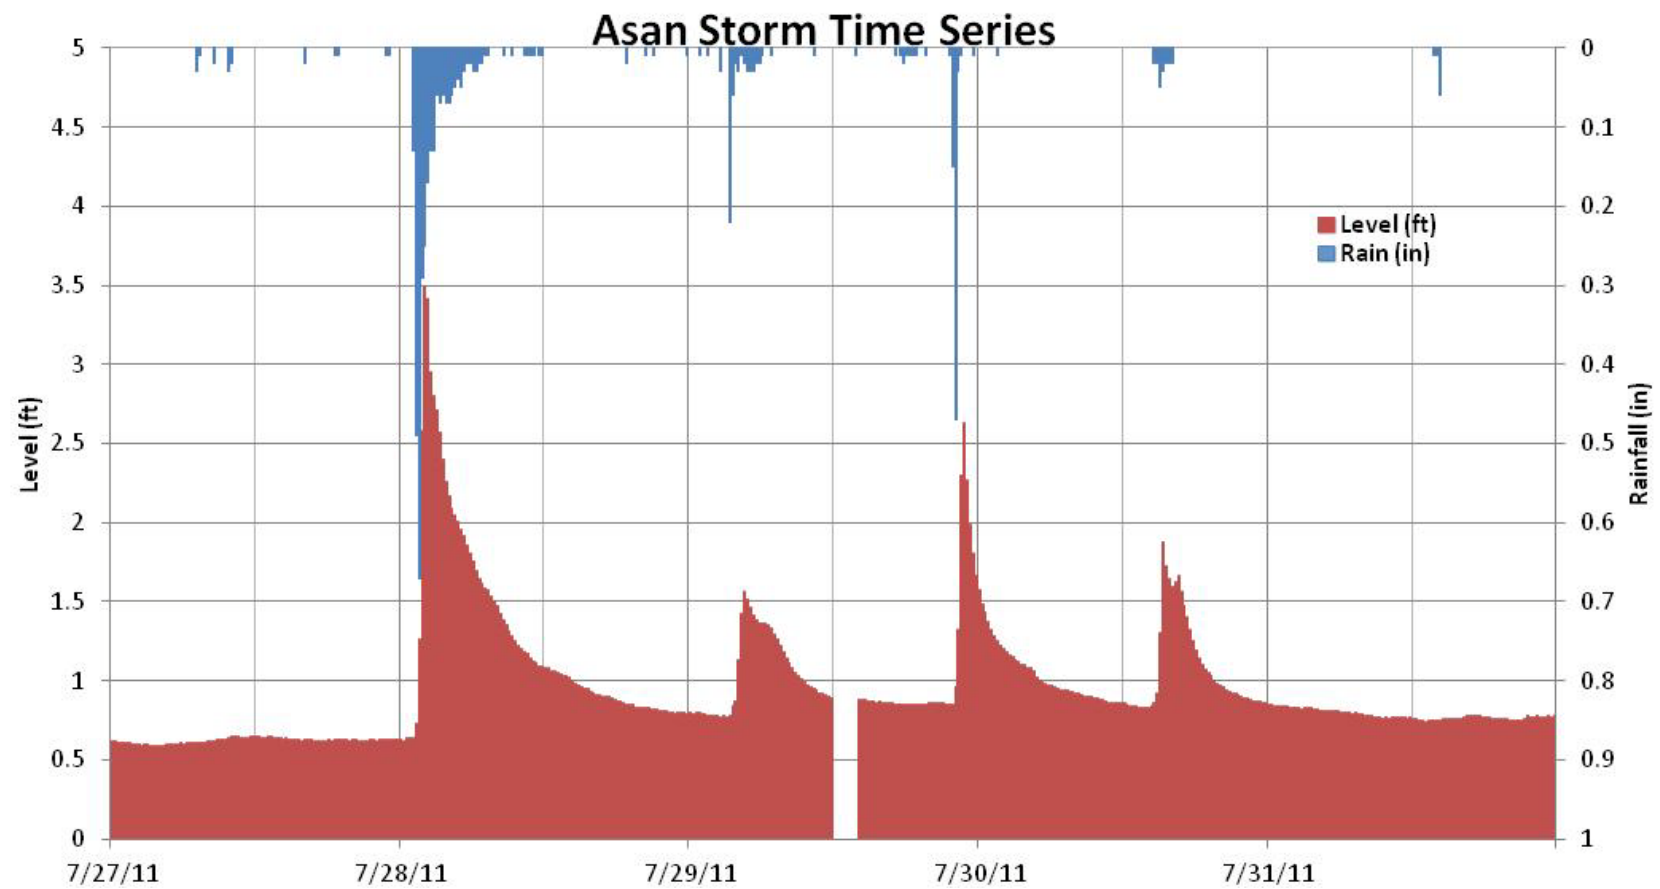
Figure 24: Asan River Storm Event

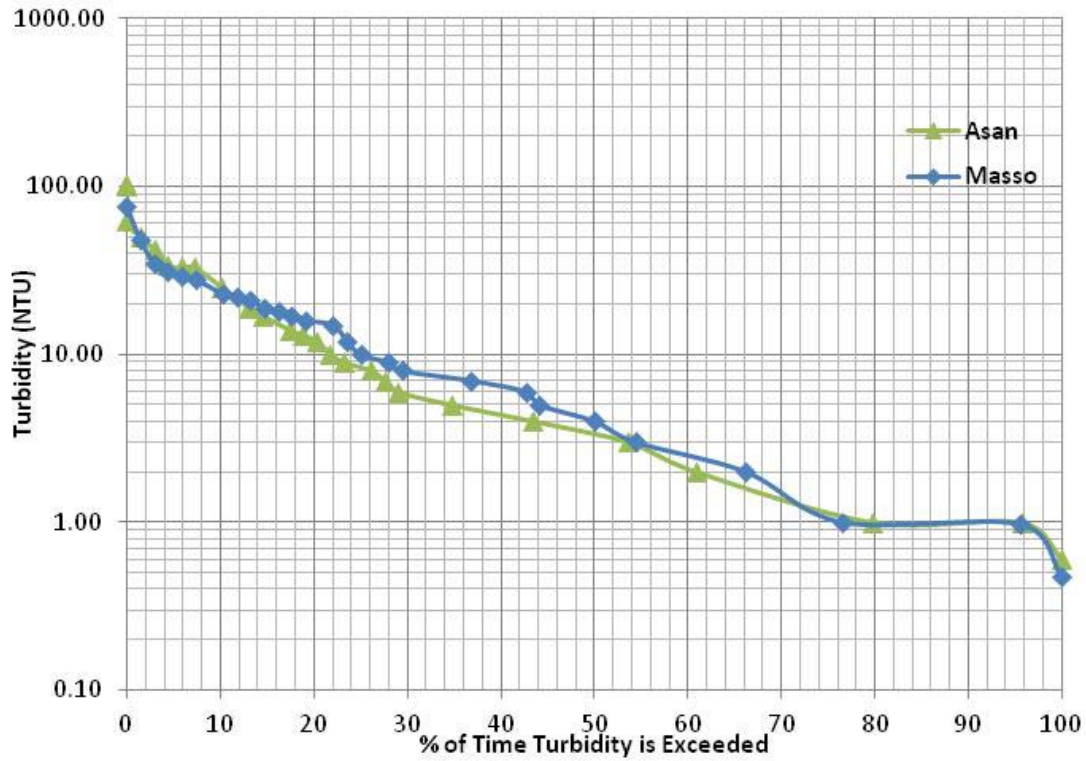
Figure 25: Turbidity duration for Masso and Asan Rivers

In order to understand the amount of turbidity found within the rivers over time, a turbidity exceedance curve (Figure 25) was created. Figure 25 measures the percent of time that turbidity was equaled or exceeded for the given river. The measure at 100% therefore indicates the base turbidity level. An examination of the graphs leads to the belief that turbidity levels for the Masso River often exceeds the turbidity in Asan River.

The lower level of turbidity shown in Figure 25 and 26 is influenced by the presence of the Masso Reservoir which is located less than a mile upstream from the Masso study site. Because of the reservoir's position downstream of most of the watershed area, much of the sediment is trapped and settled to the bottom of the reservoir before reaching the Masso study site during low rainfall events. During high rainfall events that cause more erosion however, the sediment carried by higher amounts of rainfall is not given time to settle in the reservoir before being carried to the study site and the river outlet.

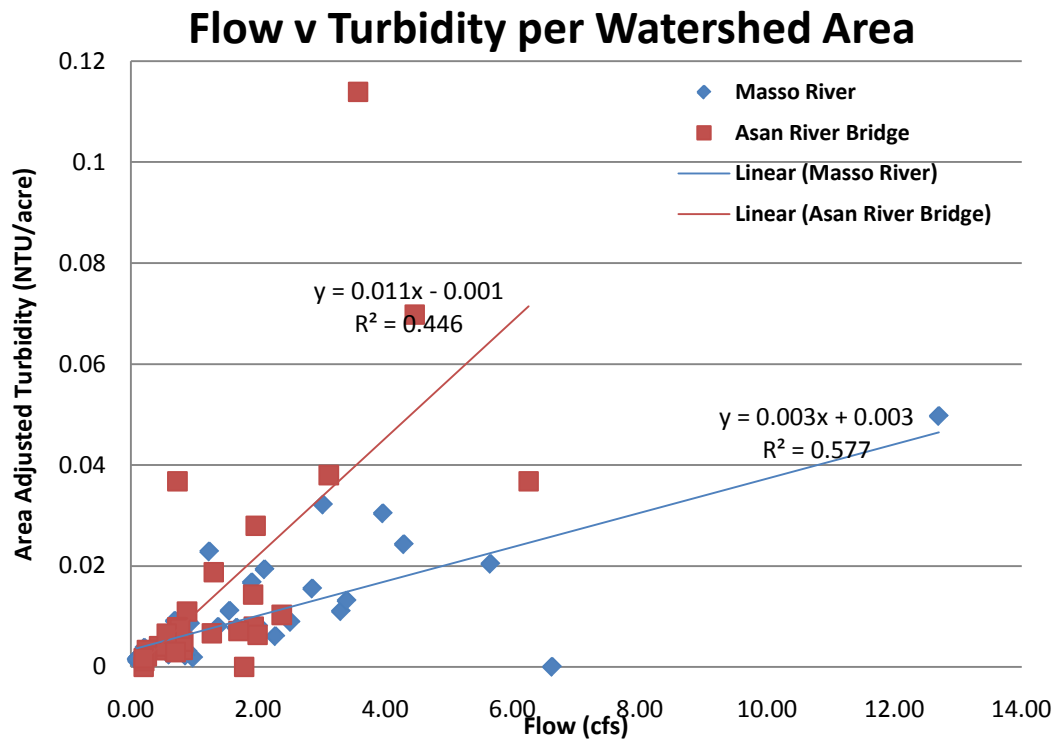
Figure 27: Flow versus Turbidity per Watershed Area of Asan and Masso Rivers

A comparison of the measured flow and the area-adjusted turbidity for the Masso and Asan Rivers (Figure 27) shows that the Asan River is more reactive to changes in flow so that more turbidity per watershed area is produced by increases in stream flow than the Masso River. The turbidity measured within the Asan and Masso rivers (Figure 27) both reflect low overall turbidity levels, with the exception of major storm events, which produced large increases in the stream turbidity. This is caused by increased upland erosion during heavy rainfall events.

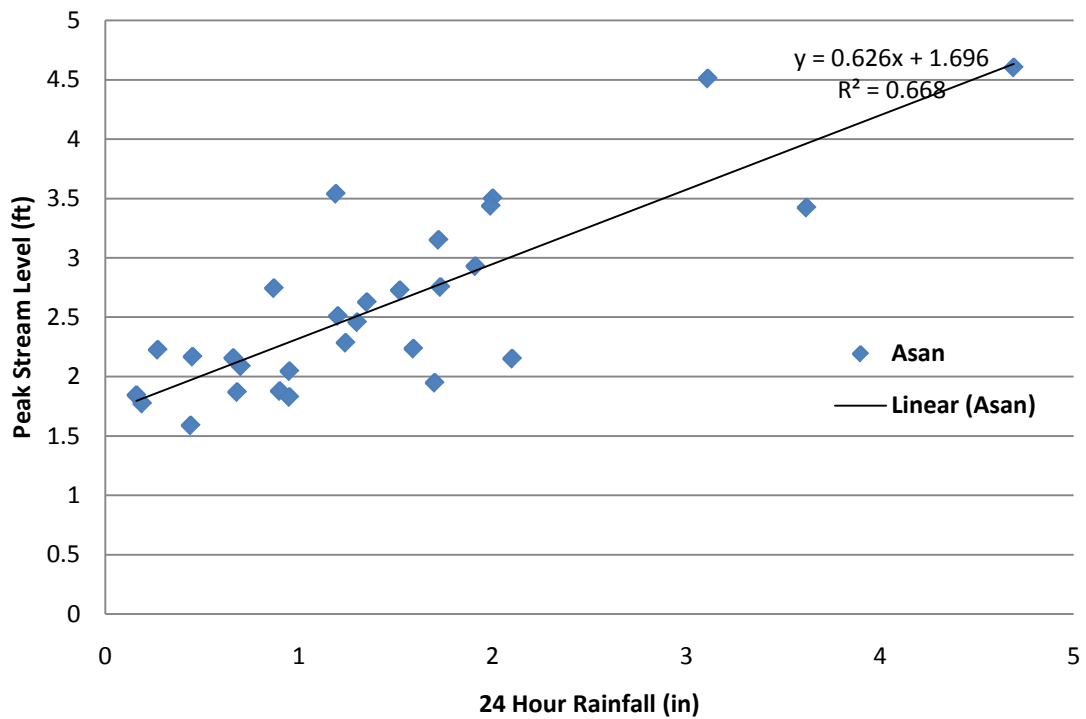
Figure 29: Rainfall versus Peak Stream Level in Asan River

Figure 28 and 29 indicate the reaction of each stream level to changes in rainfall for the Masso and Asan Rivers respectively. As shown by Figure 28, the level change for the Masso River reacts within a short response time to large changes in rainfall. In contrast, Figure 29 shows that the Asan River responds with a lower change in river level overall within the 24 hours prior to rainfall events, which can be attributed partially to the widening that is occurring in the lower Asan River.

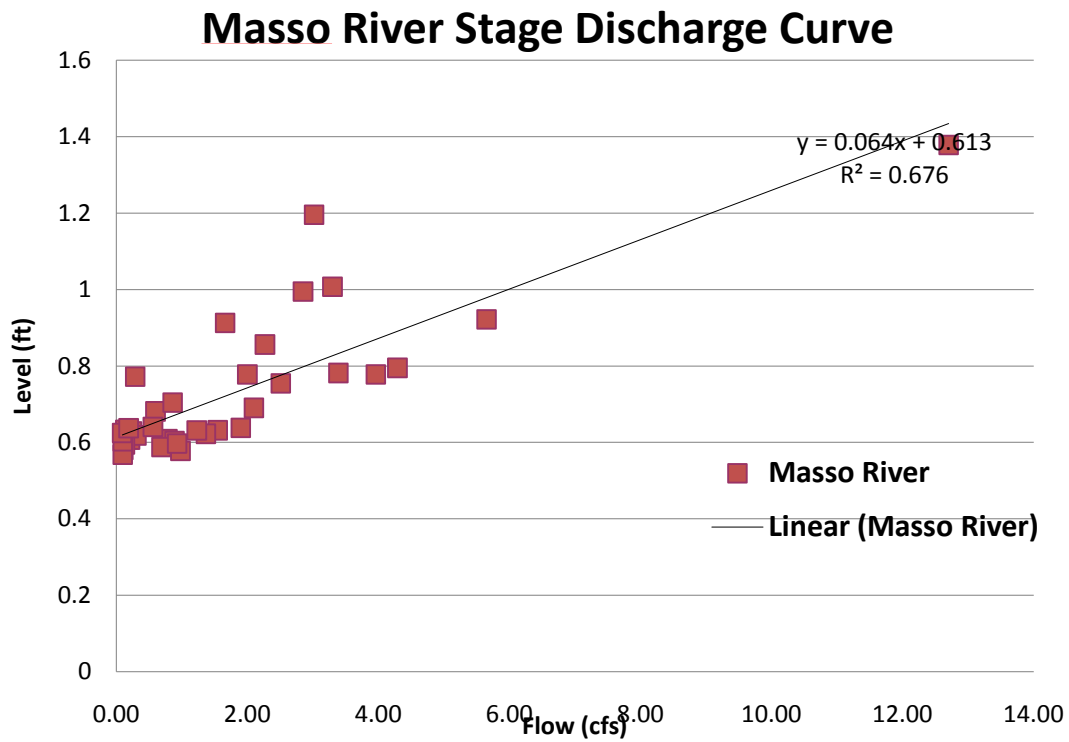
Figure 30: Masso River StageDischarge Curve

The stage discharge curves developed for this study utilized only one-year of data collected. Therefore, this does not provide a fully accurate estimate of the flow and water level relationship of the Masso and Asan Rivers. However, the stage discharge curve developed can serve as the basis for future hydrologic studies within the Piti- Asan Watershed. It is recommended that flow and level recordings of the Asan and Masso Rivers continue to be measured in order to obtain a more accurate estimate of the watershed behavior for future studies.

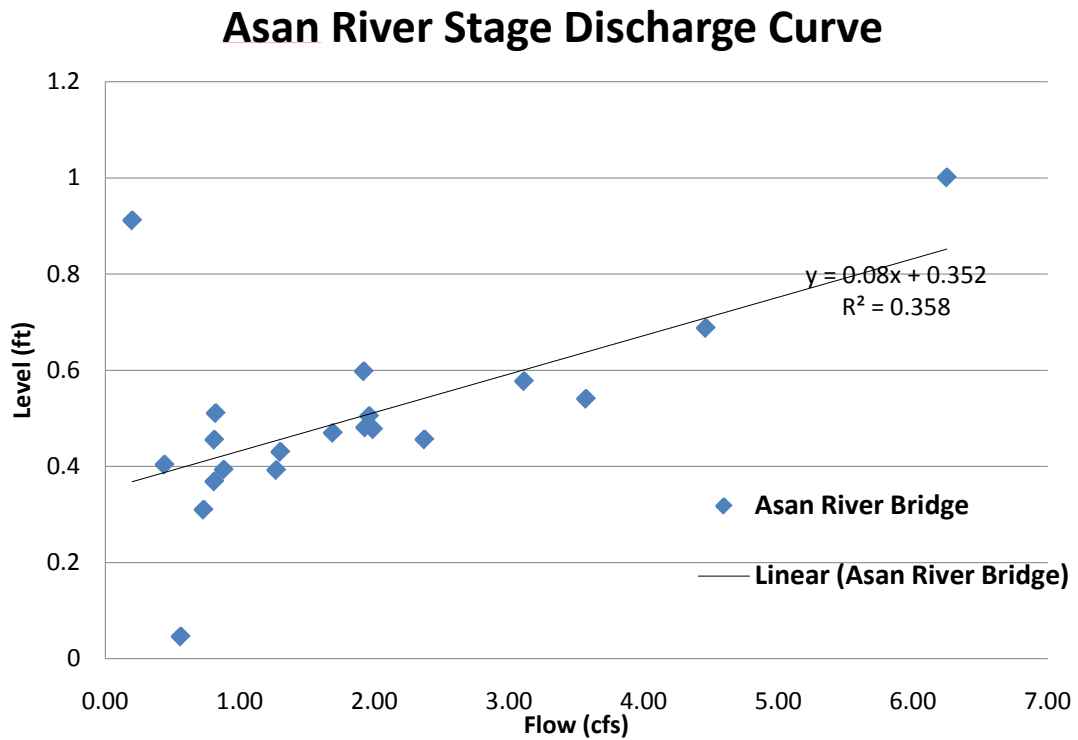
Figure 31: Asan River Stage Discharge Curve

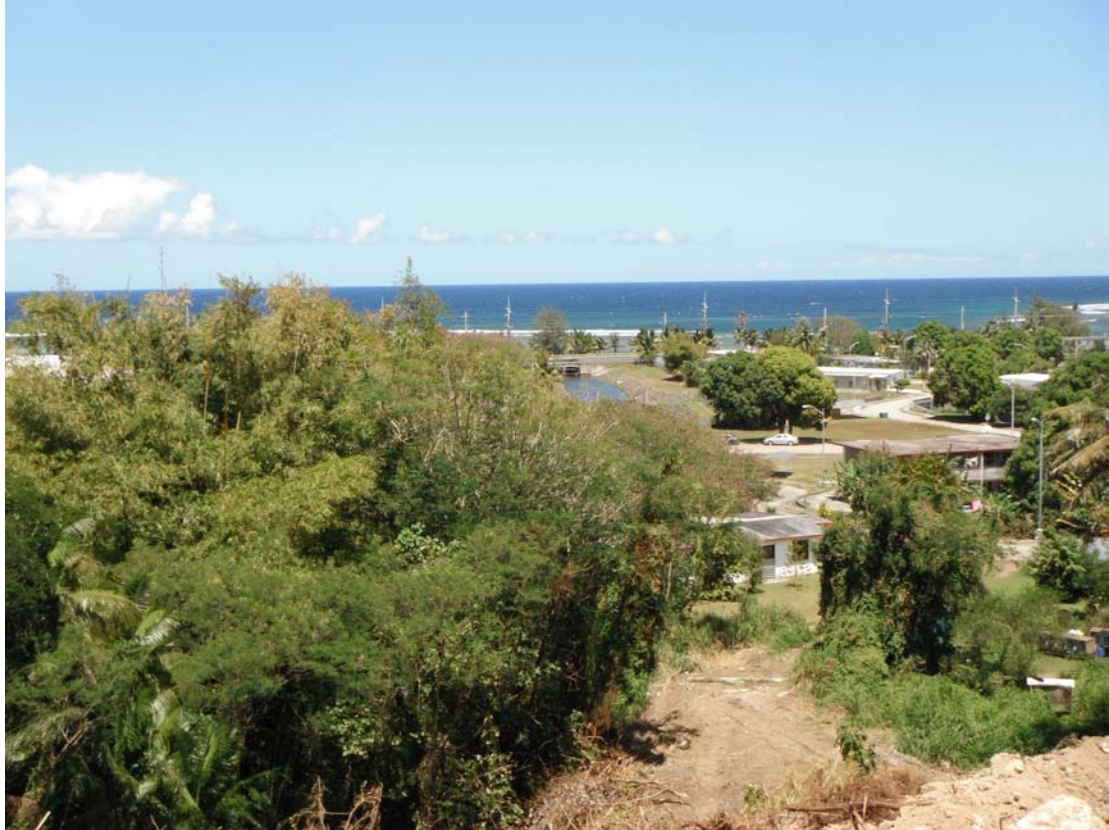
Figure 41. Cleared Site for Construction without Mitigation Efforts and Located within Close Proximity of the Asan River

Other activities within the Asan Watershed include uncontrolled clearing and grading activities, which have been observed within close proximity to the river (Figure 41). Such activity will result in additional contribution of inland soils into the Asan Bay. Although the soil in both watersheds is highly erosive, the increased activity within the Asan Watershed is accelerating the natural rate of erosion in the area. Without proper erosion control efforts surrounding existing housing and proposed development especially within 100 meters of the river, the outlets will be prone to increases in sedimentation from inland erosion.

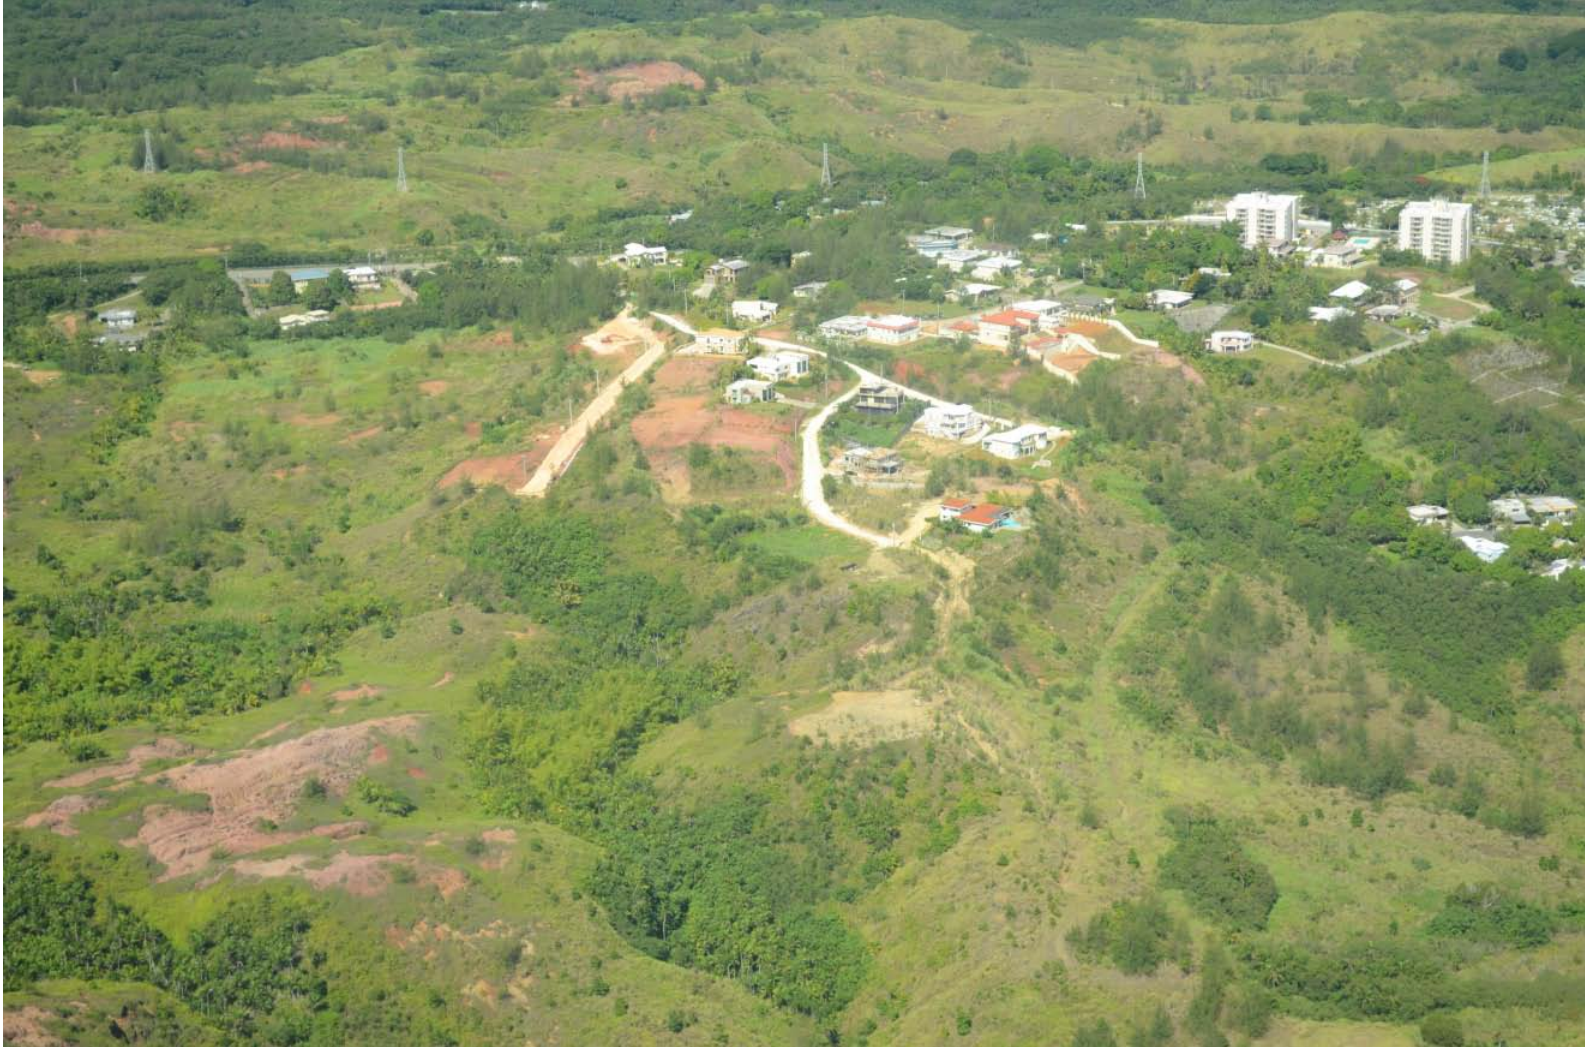
Figure 43: Sample Imagery of a High Erosion Contribution Area (June 20, 2012)

The use of GIS in the production of the estimates of soil loss allow for the visual interpretation of areas most under need of erosion controls. Figure 42 was created using the existing conditions within the 100 meter river buffer so that the location of areas needing the most attention can be easily identified. One such area includes Figure 43, which shows a badland area and construction area

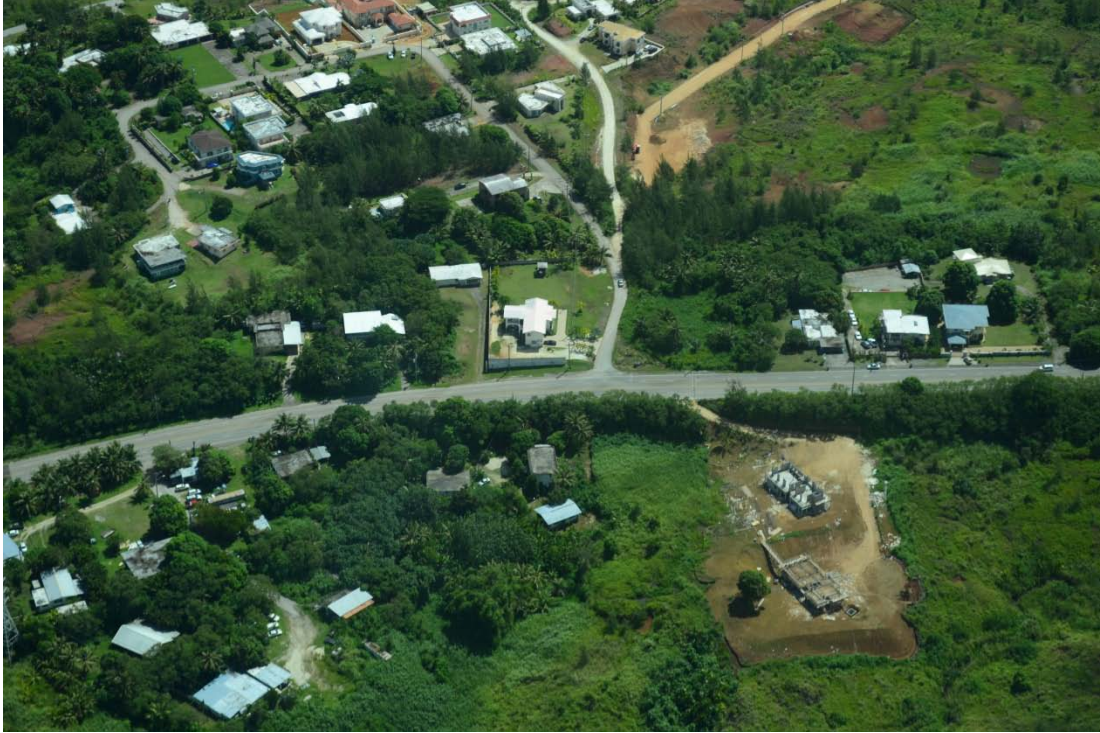
Figure 44: Masso Lot Construction (July 12, 2012)

The steep slopes along the length of the river contribute to the high potential erosion areas near Masso River. There is one private lot (Figure 44) currently being developed along the Masso River that could be contributing to erosion and sedimentation within the Piti Watershed. However, the development is small compared to the developments being proposed in Asan.

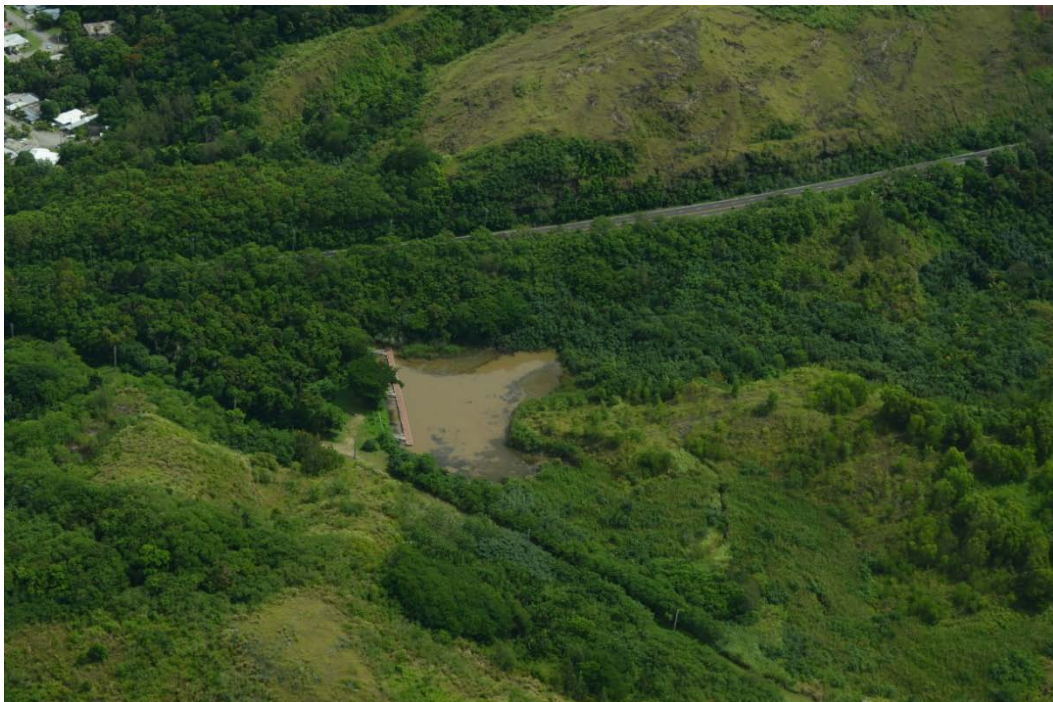
Figure 45: Masso Reservoir (June 7, 2011)

The overall difference in turbidity observed within the Masso River and Asan River studies can be affected by differences in construction and development levels within the two watershed areas. The turbidity can also be influenced by the presence of the Masso Reservoir (Figure 45) located upstream of the Masso study site and its location downstream of a large length of the river. This location has been observed to collect sediment from upstream and can diminish the contribution of most of the sediment into the Piti Bay.

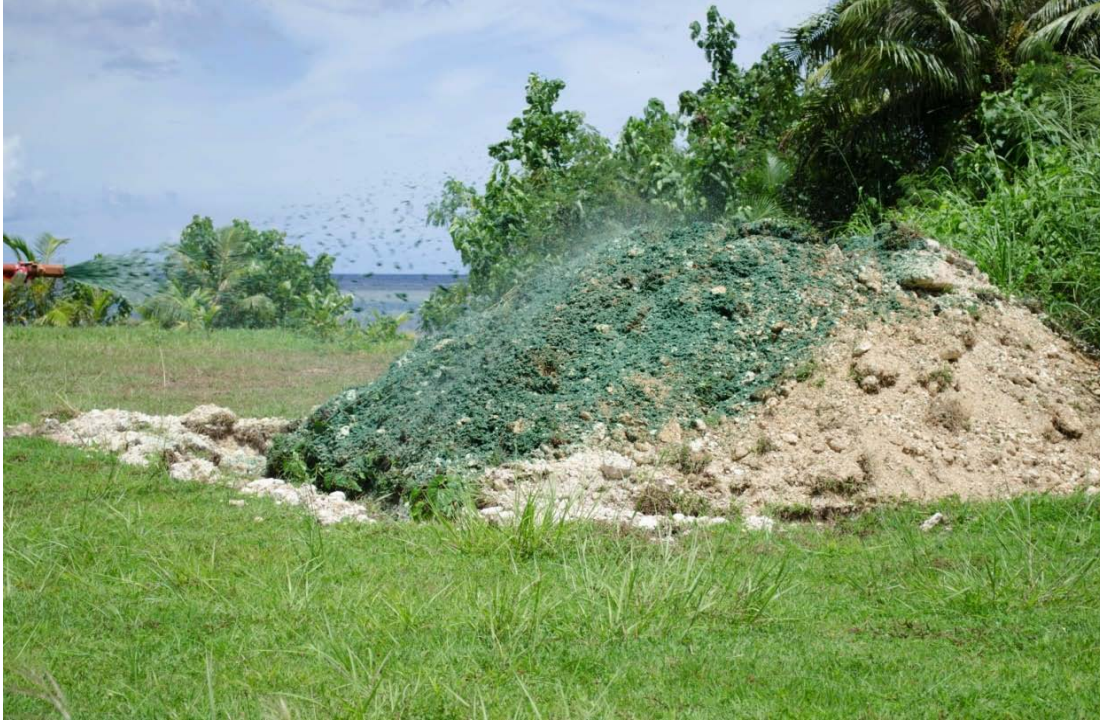
Figure 46: Hydroseeding

Slope stabilization using grass seeding (Figure 46), erosion blankets (Figure 47), or other slope stabilization methods to stabilize eroding sites, especially within 100 meters of river bodies, would minimize soil loss near river bodies. Some grasses identified as suitable for waterway or exposed soil stabilization include

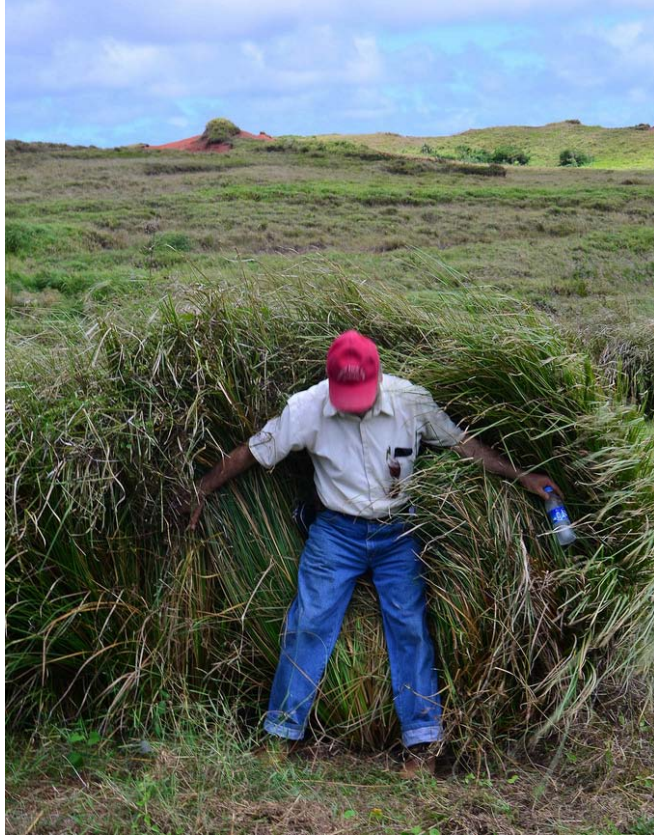
Figure 48: Vetiver Grass Hedgerow

Seeding with hedgerows of vetiver grass (Figure 48) along high erosion potential areas can have the benefit of not only a reduction of sediment contribution to rivers, but also act as a form of filtration treatment to remove other pollutants carried by runoff (Truong et al, 2000). Commercially sterilized vetiver is the preferred species to treat erosion on Guam. This type of vetiver is noninvasive because it does not produce fertile seeds and therefore does not pose a risk to outcompete native vegetation. Seeding of grasses improves slope stabilization and soil conditions so larger native vegetation can be reestablished in the area.
