# **A GIS- BASED WATERSHED MANAGEMENT PLAN FOR THE PITI-ASAN WATERSHEDS**

**Technical Report No. 139**

**October 2012**

*This project is funded by the National Oceanic and Atmospheric Administration  
through the Guam Coastal Management Program, Bureau of Planning,  
Government of Guam Project no. CRI-GU-10.*

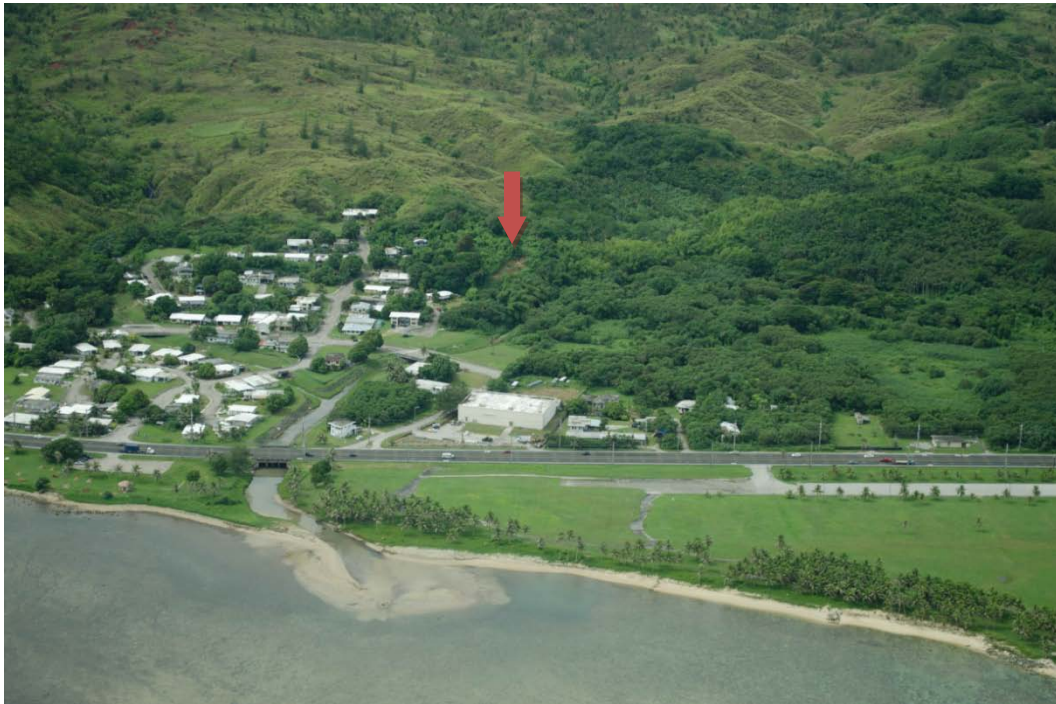
Figure 49: Cleared Lot without ESC Measures near Asan River

More stringent policies and enforcement of erosion control methods in construction and development, especially along river bodies could minimize water pollution contributed to water bodies during and after construction. Construction occurring within the watershed, especially near water bodies should be conducting erosion and sedimentation control (ESC) practices throughout the duration of construction projects. Figure 49 shows one such site that should have ESC practices in place, but lacked any form of erosion control on site despite the close proximity to the Asan River. Some recommended construction practices include the proper use of silt fencing, compost socks, berms, swales, vetiver hedge rows, or temporary sediment traps.

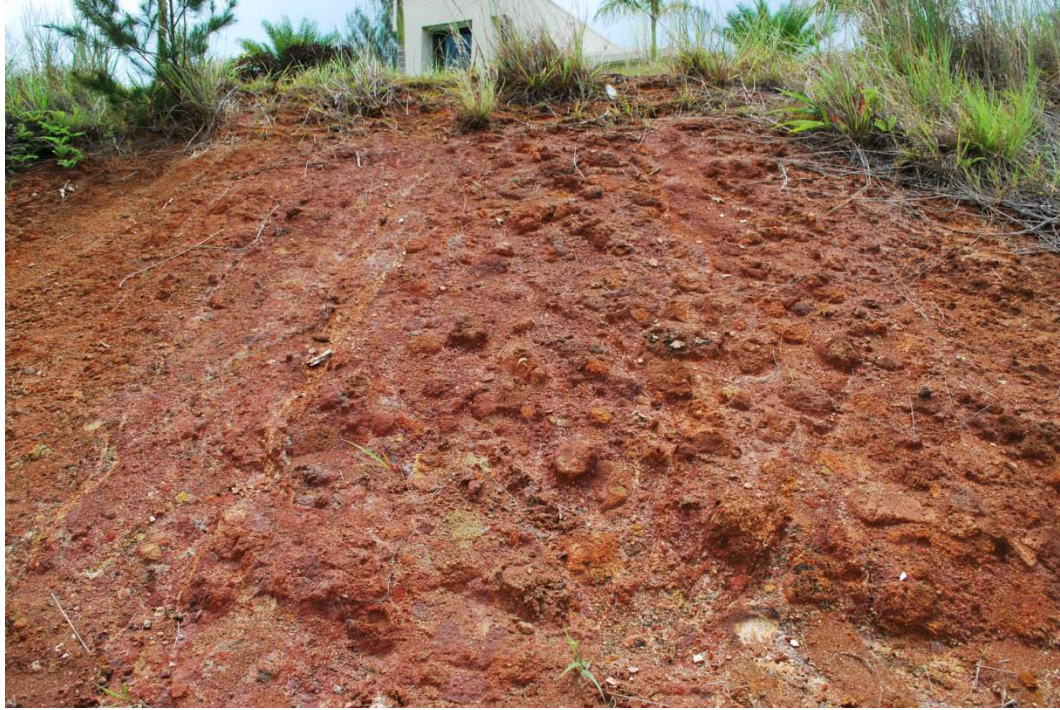
Figure 50: Site for Suggested Soil Stabilization

ESC practices are recommended for existing structures. These suggestions should be especially enforced in areas prone to landslides and close to river bodies. This includes slope ESC for homes built on steep slopes (Figure 50). Stabilization of the mouth of the river bodies is also recommended to reduce erosion at river outlets.
