ASSESSMENT OF TURBIDITY IN THE GEUS RIVER WATERSHED IN SOUTHERN GUAM

University of Guam
Water and Environmental Research Institute
of the Western Pacific
UOG Station, Mangilao, Guam 96923

**Technical Report No. 156
June 2015**

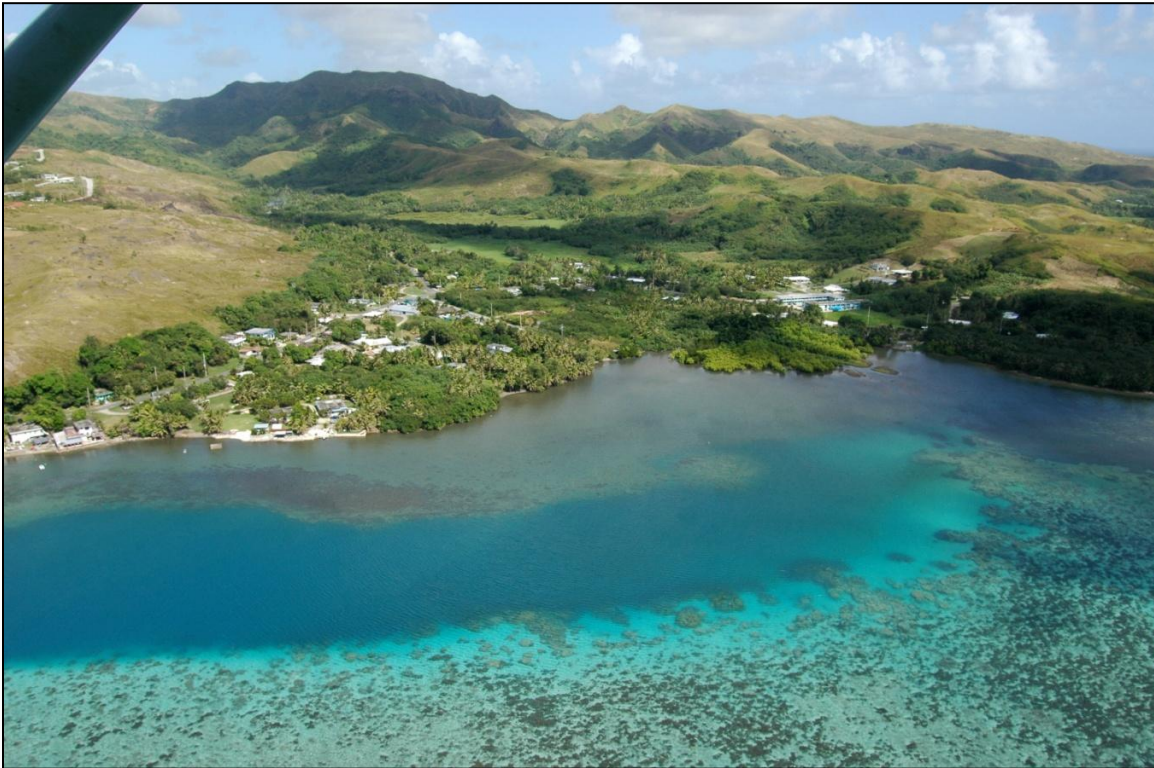
Figure 2. Aerial photograph of the Geus Watershed discharge location along the coast (Khosrowpanah et al., 2007b).

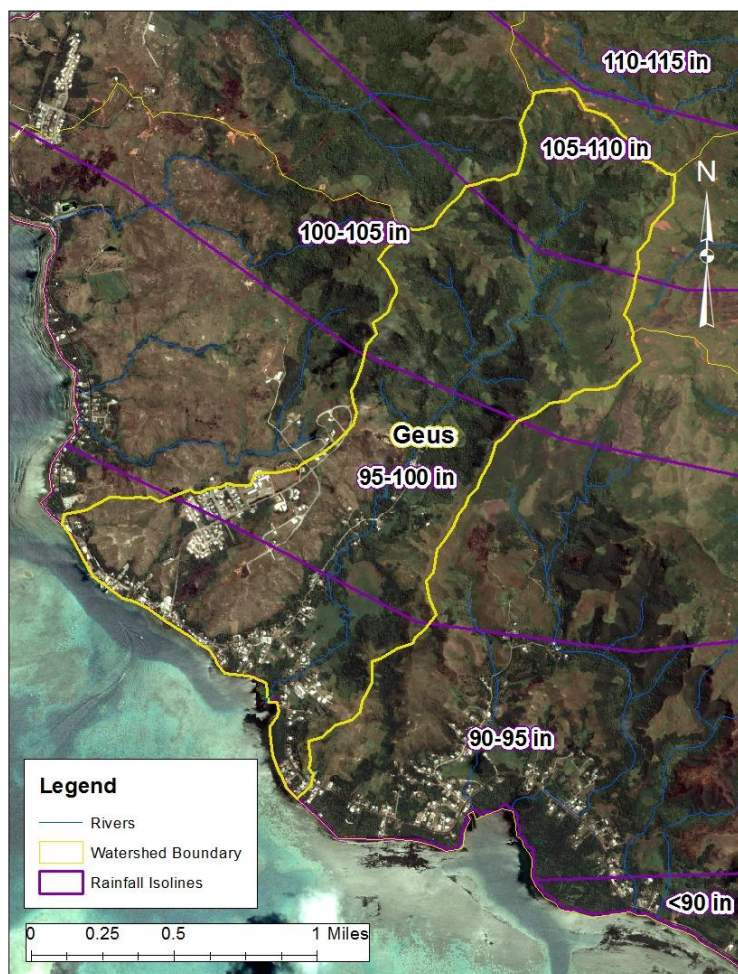
Figure 3. Average annual rainfall distribution over the Geus Watershed (Lander and Guard, 2003).

Locally, rainfall distribution is influenced by topographical variances and the general orientation of the island except during the more extreme rain events (Lander and Guard, 2003). In general, rainfall patterns are oriented in a north-northeast to south-southwest manner. However, rainfall during typhoon conditions is distributed based on the structure and path of the storm. Average annual rainfall over the Geus Watershed ranges from 90 to 95 in (2,290 to 2,410 mm) along the coast to 105-110 in (2,670-2,790 mm) atop the inland mountains (Figure 3).

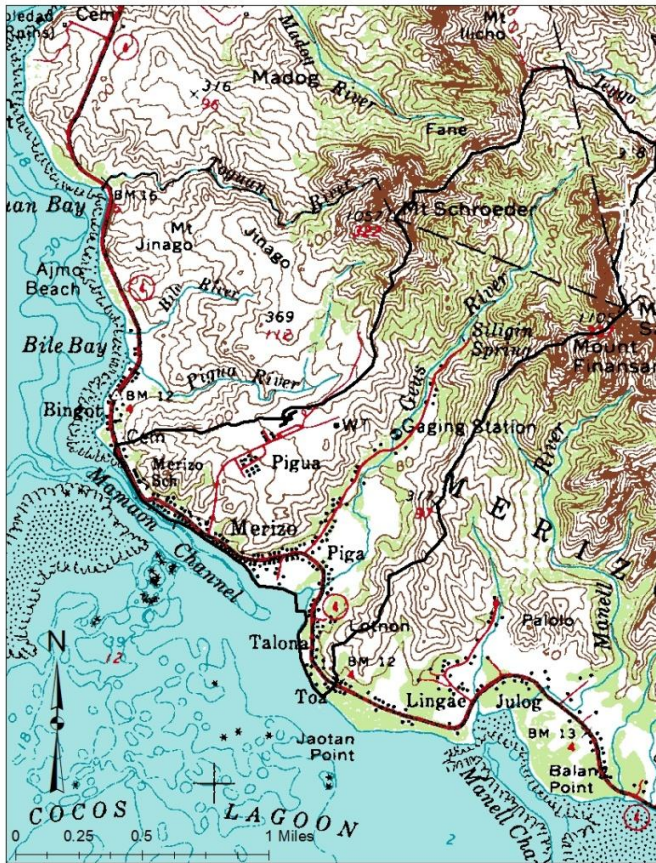
Figure 4. USGS Topographic Map

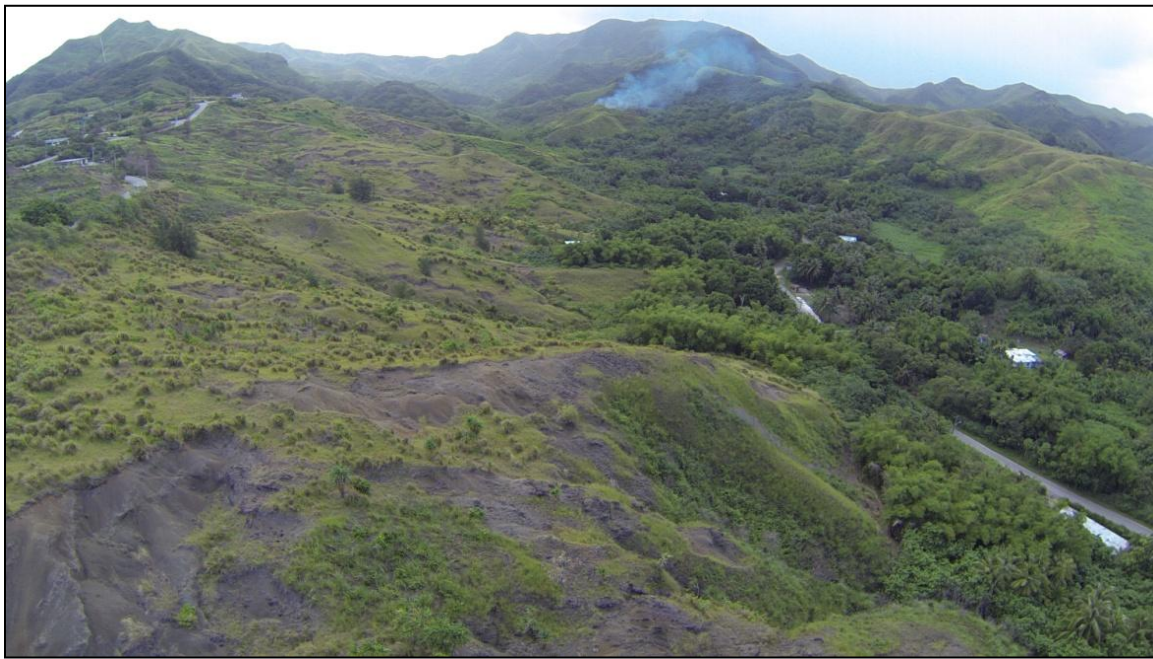
Figure 8. Aerial photograph in the Geus Watershed in southern Guam (June 17, 2014).

The upper reaches of the Geus River and its upland tributaries are largely forested, grading to grasslands and some badlands on the surrounding high slopes (Figure 8). There is very little off-roading in this watershed, with some four-wheel traffic (mainly hunters) along the ridges on the north and east sides of the watershed boundary. The uplands contain many early Chamorro artifacts. There are likely a very large number of ungulates (wild pigs and deer) inhabiting the area. Wildfires are common in the dry season, and occur primarily in the grassy areas located on the steep slopes and highest terrain of the surrounding mountains.

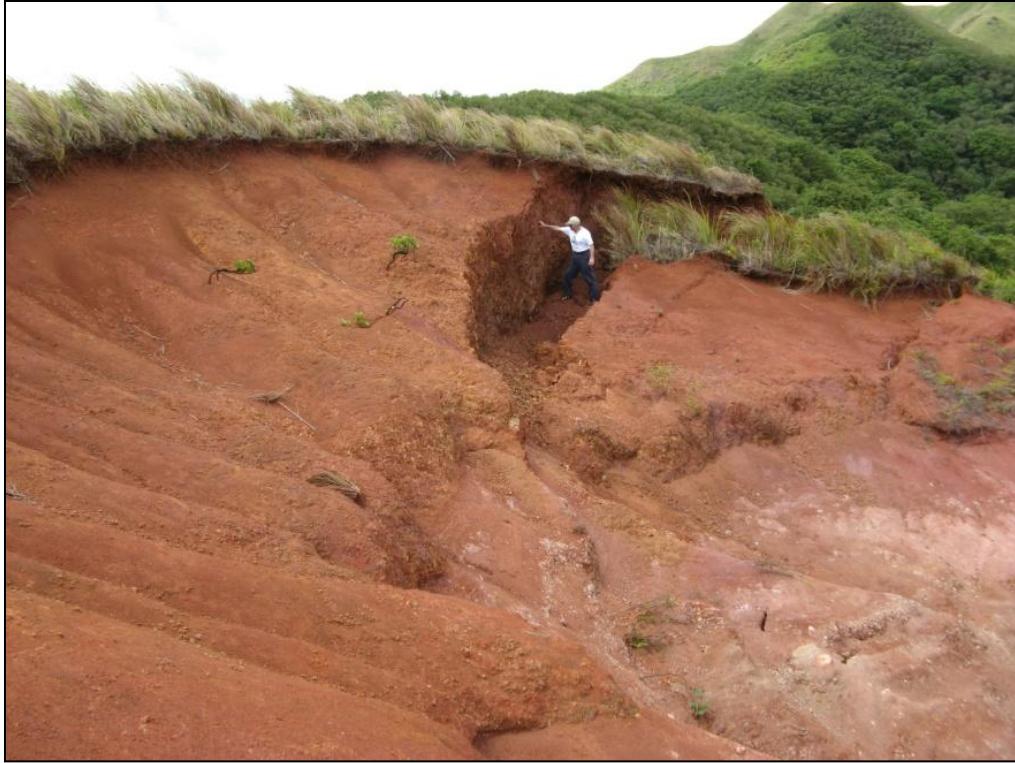
Figure 9. Badlands atop the Pigua Ridge in Merizo, southern Guam (March 15, 2014).

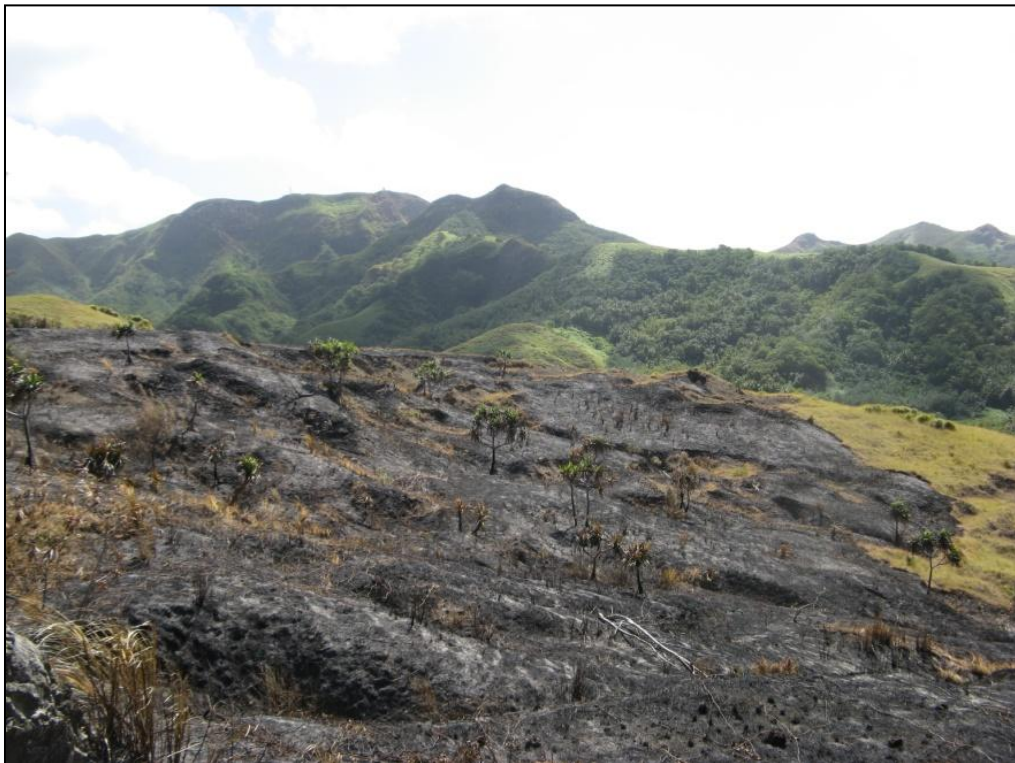
Figure 10. Burned Savanna along the Geus Slopes in southern Guam (April 2, 2014).

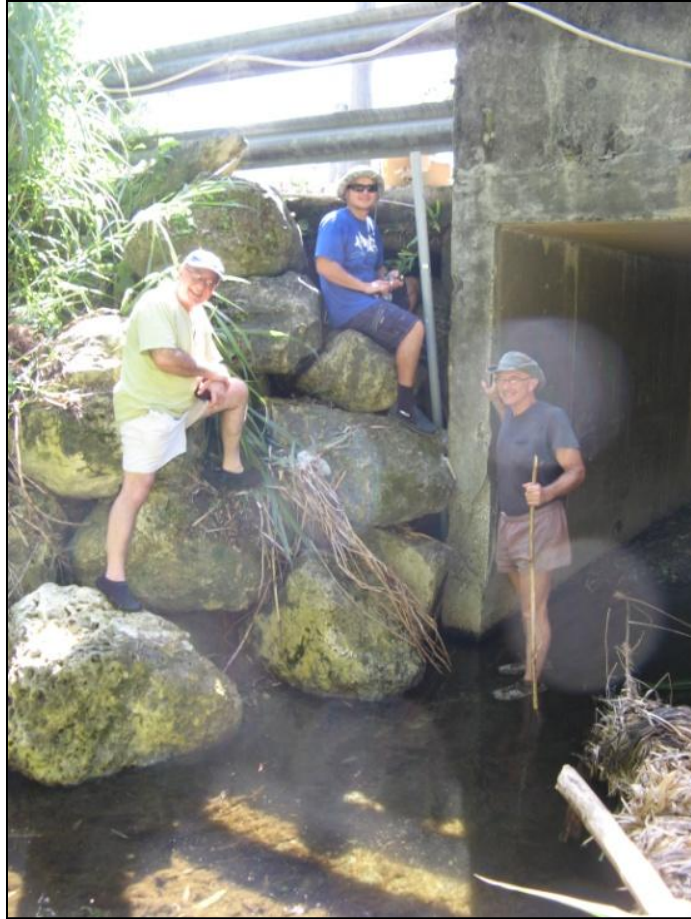
Stream level is simply the height of the Geus River water column at the data collection site. Stream level was measured using two HoboWare® U20 water level data loggers with a range of 0 to 30 ft and an accuracy of 0.015 ft (Figure 12 and 13). The level loggers were collocated with one level logger resting at the bottom of the water column and the other logger outside of the water column to account for atmospheric pressure variations. Pressure readings were collected at 5-minute intervals, and the pressure difference between the river level logger and the atmosphere level logger provided the pressure (in psi) attributed to the water column. During data post-processing, a correction factor was applied to account for the actual location of the pressure sensor based on its orientation in the PVC housing and stream level baseline height established during dry season conditions. This was necessary to provide a more accurate stream level height and a consistent reference point for the stage discharge curve.

Figure 12. Installation of data loggers in the Geus River in southern Guam (January 15, 2014).

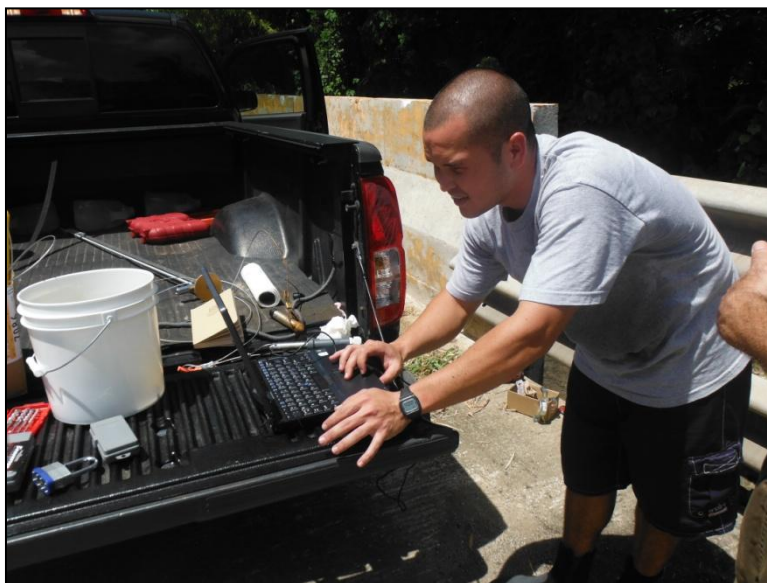
Figure 13. Field download of Geus River data logger information (March 5, 2014).

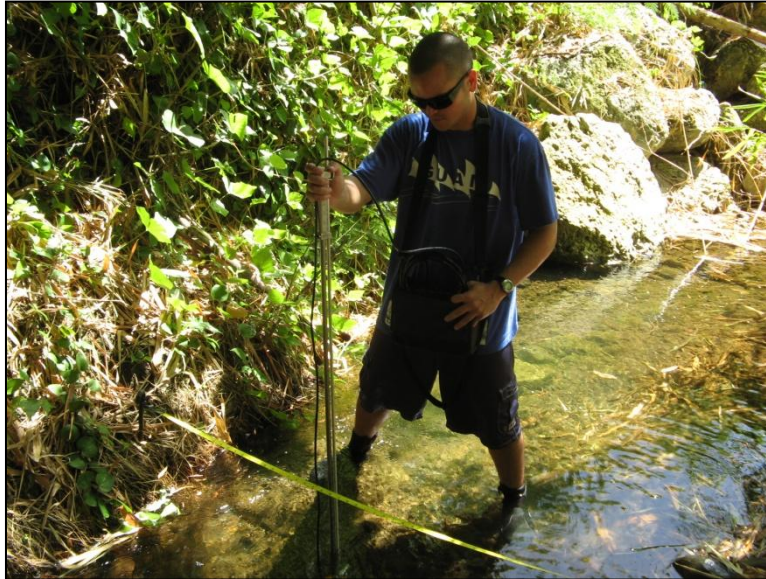
Stream flow was measured close to the primary data collection station during weekly site visits (Figure 14). A Flow-mate™ Model 2000 Portable Flowmeter was used to collect readings (in cfs) along a transect set perpendicular to flow direction. A correlation between total flow and stream level over time produces a discharge rating curve.

Figure 14. Stream flow measurement in the Geus River in southern Guam (January 15, 2014).

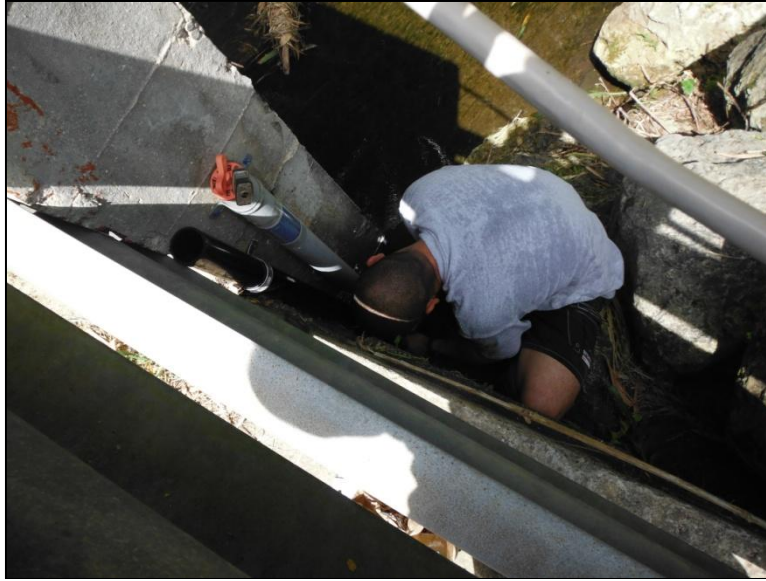
Turbidity was measured using a turbidity logger and a hand-held turbidity meter. An Analite NEP495P Turbidity Logging Probe was installed to collect turbidity readings at 15-minute intervals in the water column (Figure 15). In addition, during weekly site visits water samples were collected and analyzed using an Omega TRH444 Portable Turbidity Meter. Both turbidimeters measure suspended particles in a solution based on the amount of light scatter produced with infrared light. Accuracy of the portable turbidity meter was verified prior to each use. The turbidity logger was calibrated prior to deployment and accuracy was assessed weekly by comparison with the portable turbidity meter. Maintenance was conducted weekly during long-term deployment and recalibration was conducted periodically as necessary.

Figure 15. Turbidimeter housing installation in the Geus River (March 5, 2014).

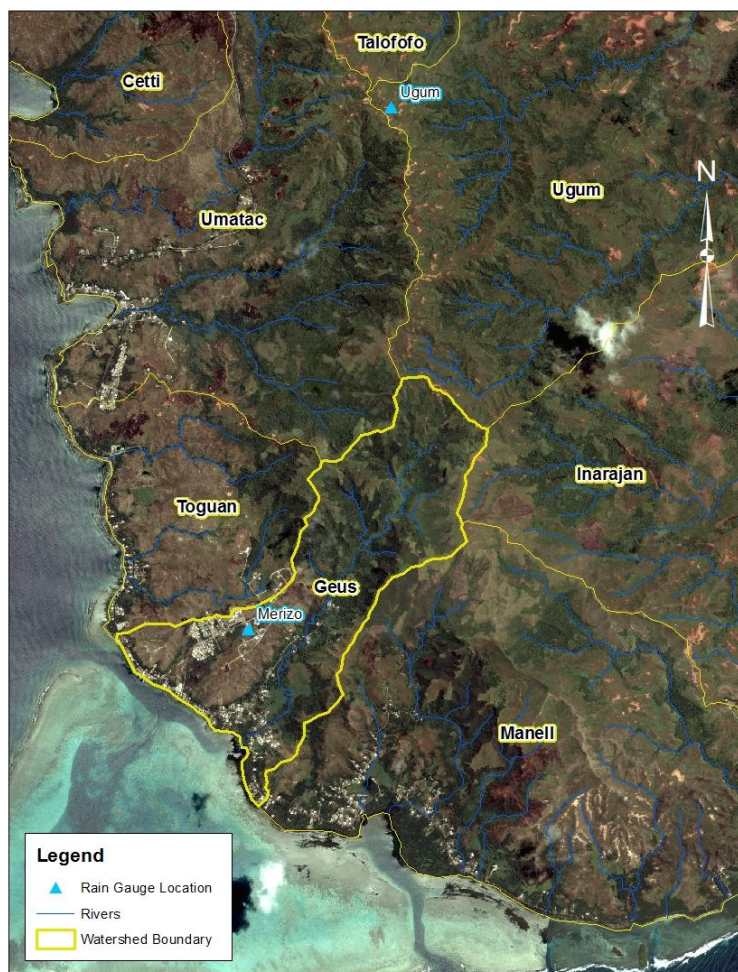
Daily rainfall quantities were recorded by a rain gauge located on the Pigua ridge just upland from the primary data collection site. Toward the later part of the data collection period the Pigua rain gauge became faulty and no longer was supplying valid data. Therefore, supplemental rainfall data was also used from a rain gauge located in the Ugum Watershed (Figure 16). The rain gauges use two tipping buckets that collect water as it falls, recording each time the tipping buckets are activated representing a specific quantity of rainfall (0.01 in per tip).

Figure 16. Rain gauge locations in and around the Geus Watershed in southern Guam.

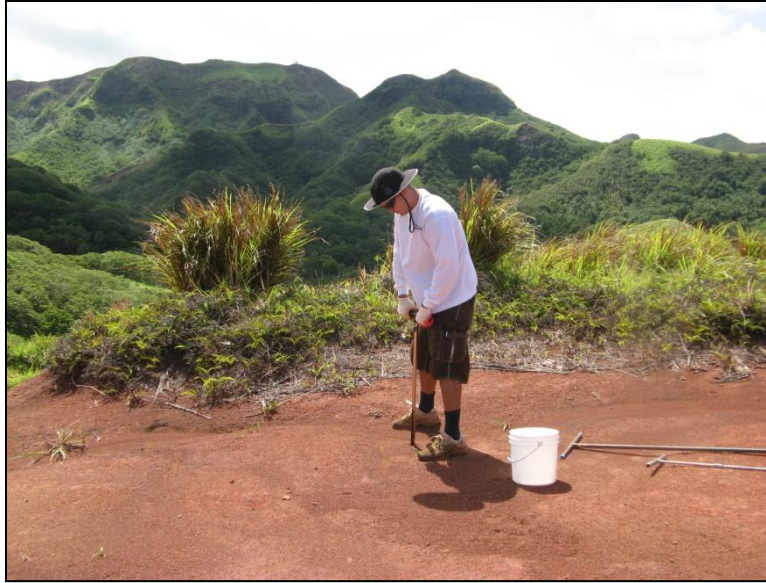
Soil samples from seven locations were collected and tested in the soil lab to identify the various soil types represented in the Geus Watershed (Figure 17 and 18). Samples were collected as composites from sample locations selected based on exposed soil observations or dominant vegetation types. Four samples were collected along the upland ridge including areas consisting of the more prominent badlands and grasslands. Three samples were collected in the interior of the valley and along the River where more forest vegetation dominates. Each composite sample consisted of five individual sample aliquots, collected to the depth of 12 in (30 cm) from the surface.

Figure 17. Soil sample collection in a badland location in the Geus Watershed (June 3, 2014).

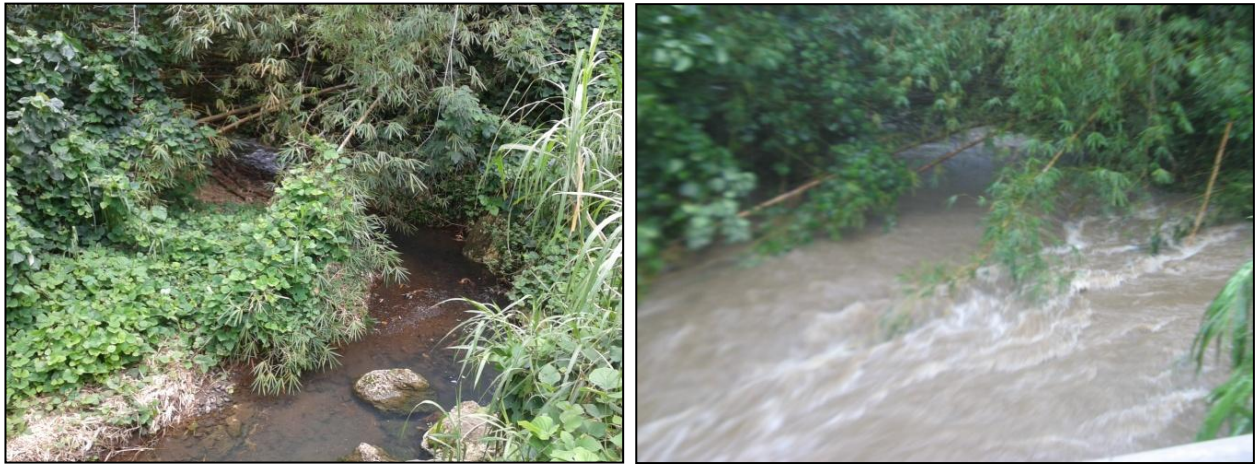
Figure 25. Geus River conditions before and during Tropical Storm Halong (July 18, 2014 and July 30, 2014, respectively)
