A Hydrogeologic Survey of Santa Rita Spring, Guam: Engineering and Design Recommendations for Rehabilitation

Water & Environmental Research Institute of the Western Pacific University of Guam, UOG Station, Mangilao, Guam 96923

Technical Report No. 172 May 2020

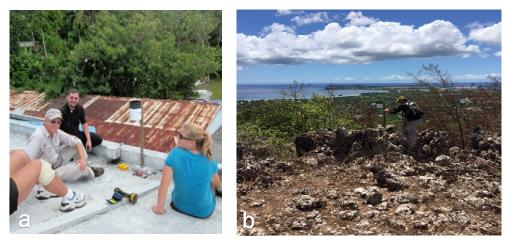
Figure 2.8. Rain gauges installed for this study. (a) SRS 1, on top of Our Lady of Guadalupe Church. (b) SRS 2 on the summit of the watershed, overlooking Orote peninsula, to the northwest, center of photograph.

To interpret the real-time spring responses to ongoing rainfall, provide redundancy, and gain some insight into the geographical distribution of rainfall within the watershed, we installed two rain gauges inside the watershed (Figures 2.1, 2.6, and 2.8), SRS 1 at its lowest elevation (Figure 2.8a), and SRS2 at its highest (Figures 2.2 and 2.8b). Rain Gauge SRS 1 was installed on the roof of Our Lady of Guadalupe Church, next to the SRS site. Rain Gauge SRS 2 was installed on the summit behind the SRS site in the old Navy quarry. The gauges were active from June 2016 to July 2018. Measurements by the two gauges are effectively identical; differences appear to be random, with an average daily difference of only 7.5% (appendix D). At least one gauge was functional at any given time. Monthly total rainfall is shown in Figure 2.9. Annual and seasonal totals are shown in Table 2.3. This record of rainfall was used to interpret spring hydrograph data (Section 2.5).

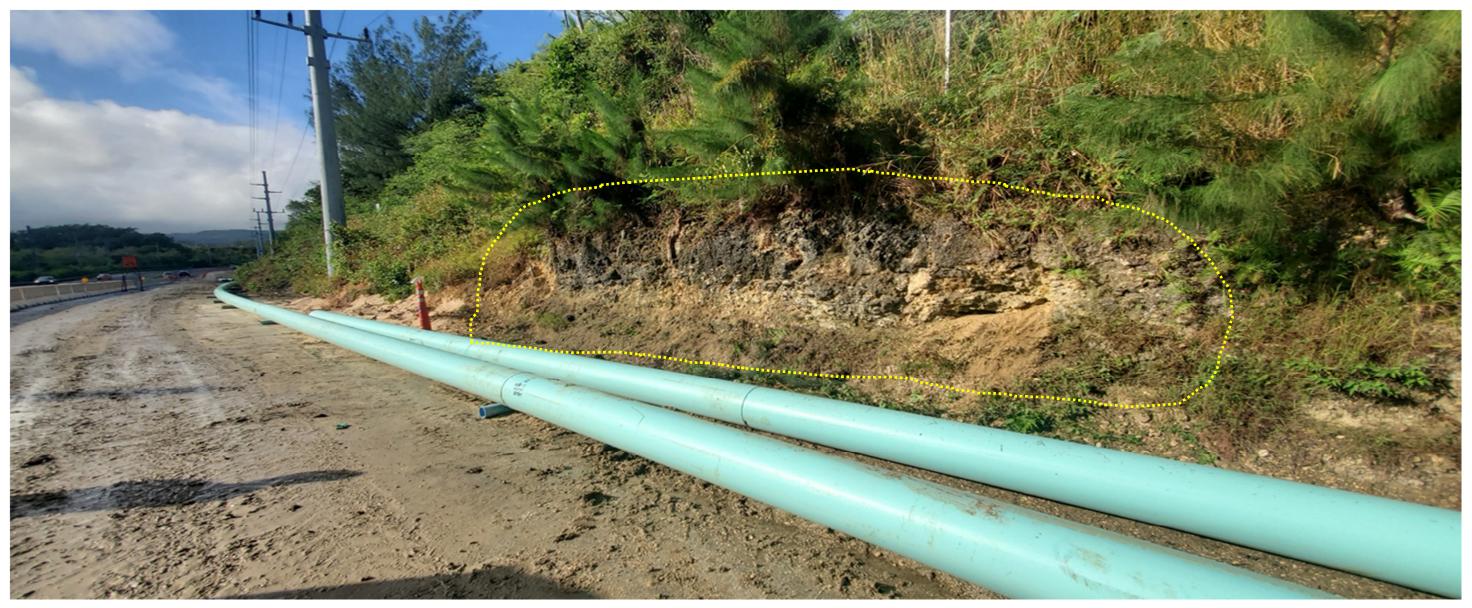
Figure 3.5. (a). Route 1 southbound shoulder showing Alifan-Talisay exposure. Yellow boxed area contains the contact between the overlying Alifan aquifer and the underlying Talisay aquiclude. The teal pipes in the foreground are new 16-in, water main for the Navy water system serving the base.

The recent installation of a new water main along the side of the road presented an opportunity to learn even more at this site, so we returned on Saturday, 11 January 2020 to study the site again and take the series of photographs shown in Figure 3.5. The texture and color of the layers seen in this exposure matched those found at the SRS site during our drilling study (Section 3.2.4).

- 1) Utilize a cutoff wall intercepting the water-bearing conduits at the contact between the overlying limestone aquifer and the underlying clayey aquiclude, the foundation for which will be set at least 1.5 ft. into the aquiclude layer (Section 3.2.2: Figure 3.5 a, b, c and d).

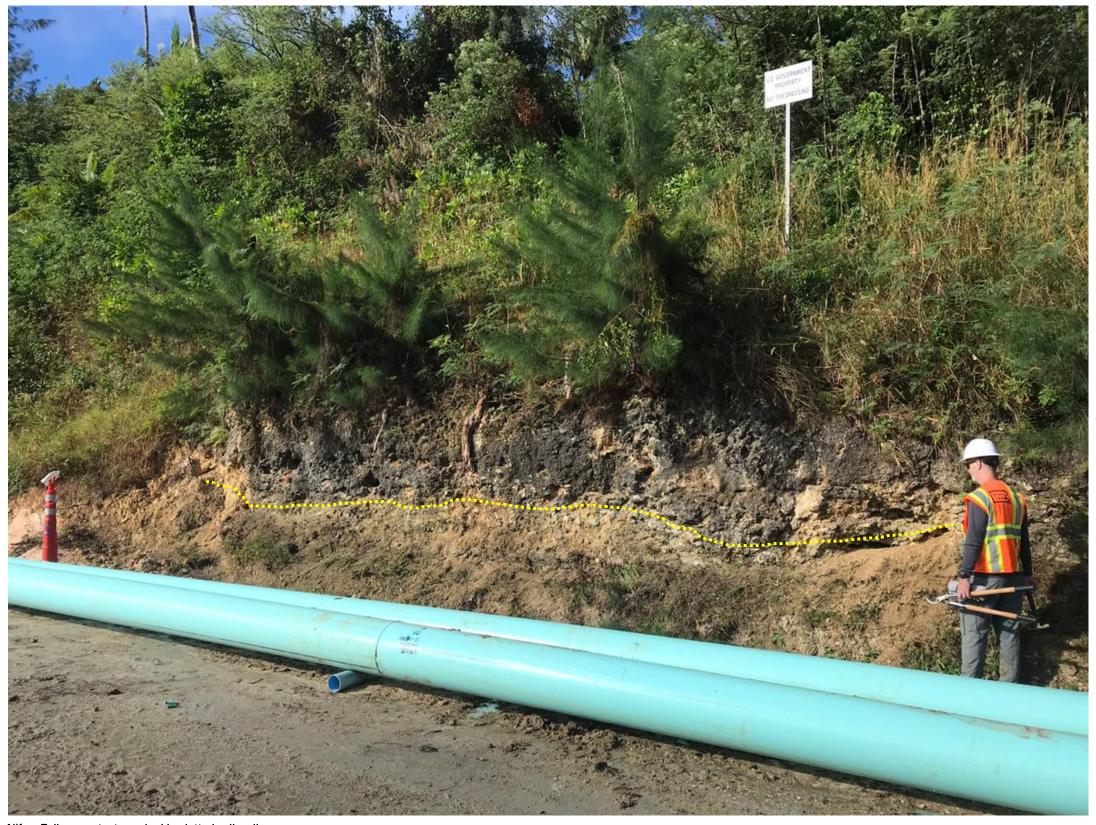
Figure 3.5 (b) Closer-in view of the Alifan-Talisay contact, marked by dotted yellow line.

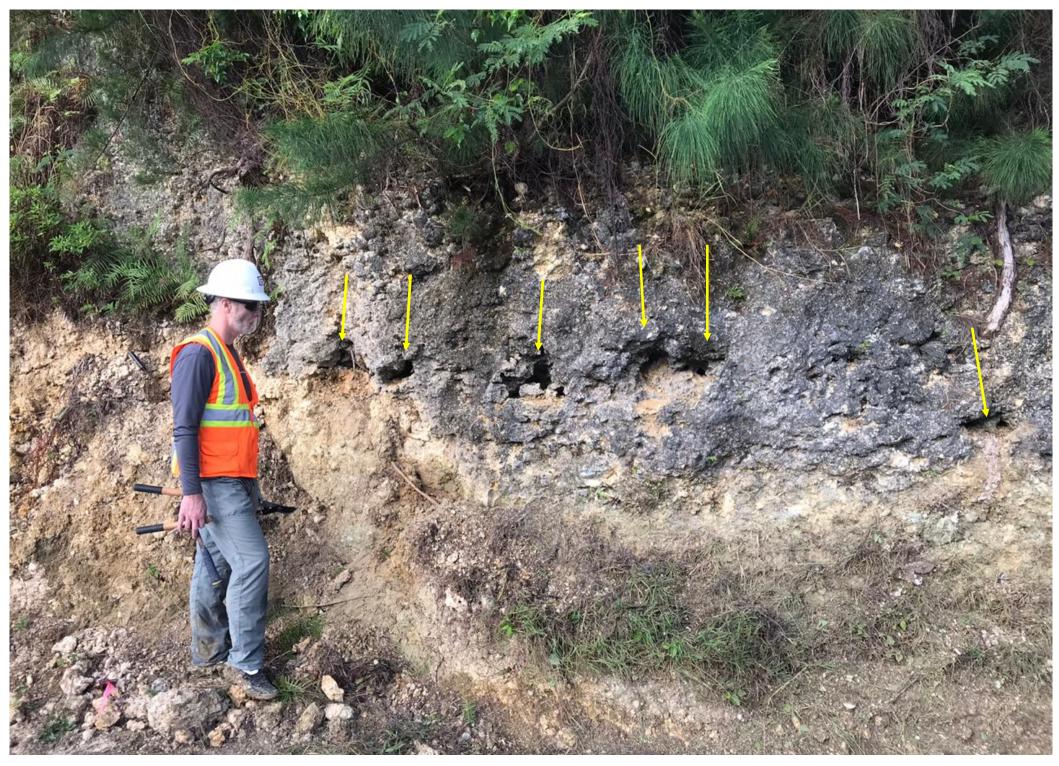
Figure 3.5 (c) Detail, showing distributed hand-scale cavernous porosity at the contact. The cut has intercepted and exposed the cross-section of a network of open conduits that have formed at the contact between the soluble, high-permeability limestone above and the insoluble, low-permeability clayey layer beneath. Although the ones seen here are inactive, conduits such as these drain the water from the overlying limestone aquifer and can be expected to be exposed at the SRS when the contact is excavated.

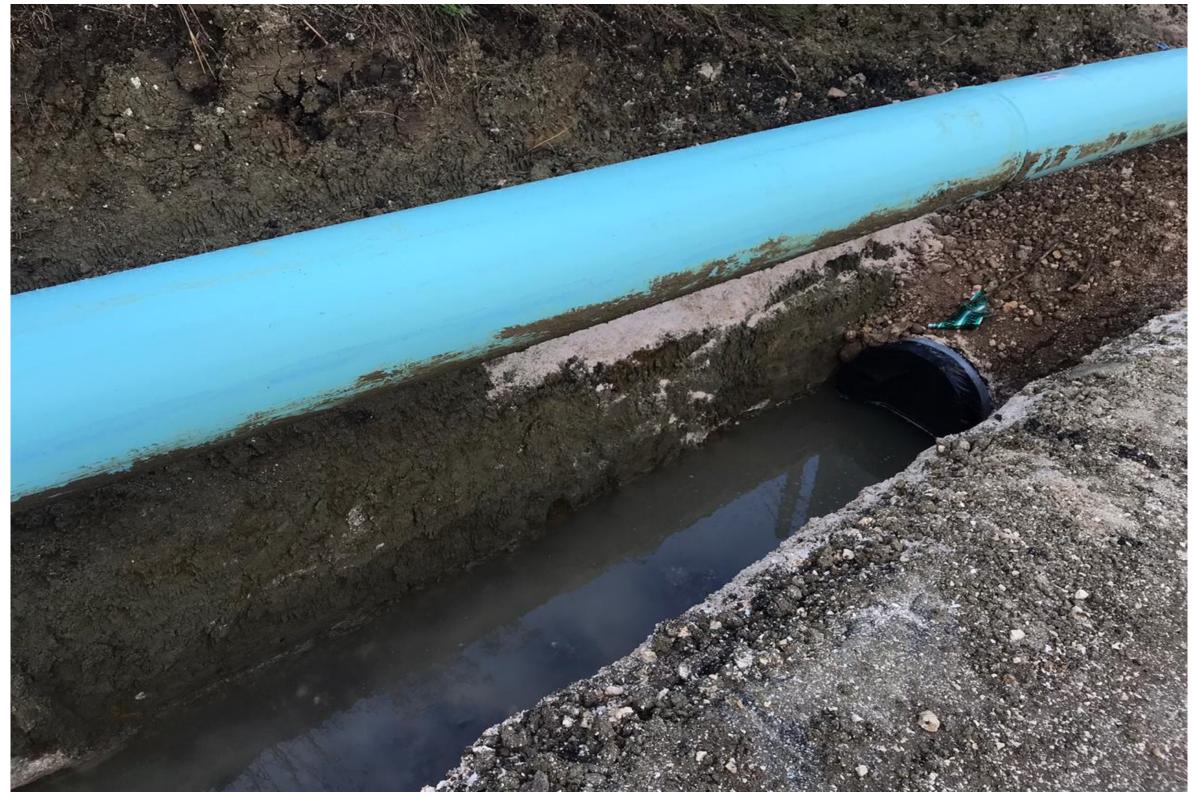
Figure 3.5 (d). Detail of trench cut in the low-permeability Talisay Member, in which the new Navy water main is being installed. Note the standing water in the trench, from recent rainfall.

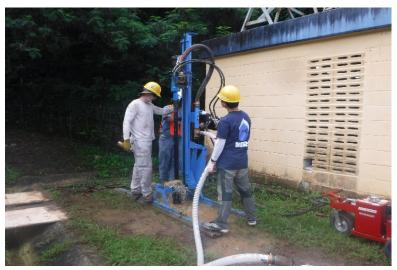
Figure 3.6. The Lonestar LH200 portable well drilling rig drilling hole 5 at the SRS.

To discern the hydrogeologic characteristics of the site—in particular, the depth to the aquiclude—we used a Lonestar LH200® portable drilling rig⁵ (Figure 3.6) to install 11 boreholes. In order to characterize the hydrology of the site, for each borehole, cuttings were collected and analyzed (Figure 3.7), and standpipes were inserted.

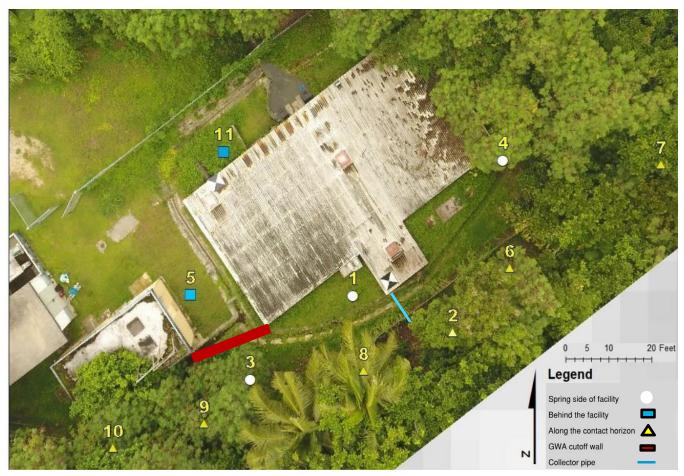
- 1) <u>Located on the spring side</u> of the existing SRS structure, close to the walls of the structure, are boreholes 1, 3, and 4 (white circles).
- 2) <u>Located behind the buried cutoff wall</u> and behind the spring holding tank on the west side are boreholes 5 and 11 (blue squares).
- 3) <u>Located along the suspected contact</u> between the Alifan Limestone and the basal Talisay Member are boreholes 2, 6, 7, 8, 9, and 10 (yellow triangles).

Figure 3.8. Locations of the Santa Rita Spring boreholes.
