QUALITATIVE EXAMINATION OF GROUNDWATER FROM YAP AND SOME OF ITS NEIGHBORING ISLANDS

Technical Report No. 115

May 2006

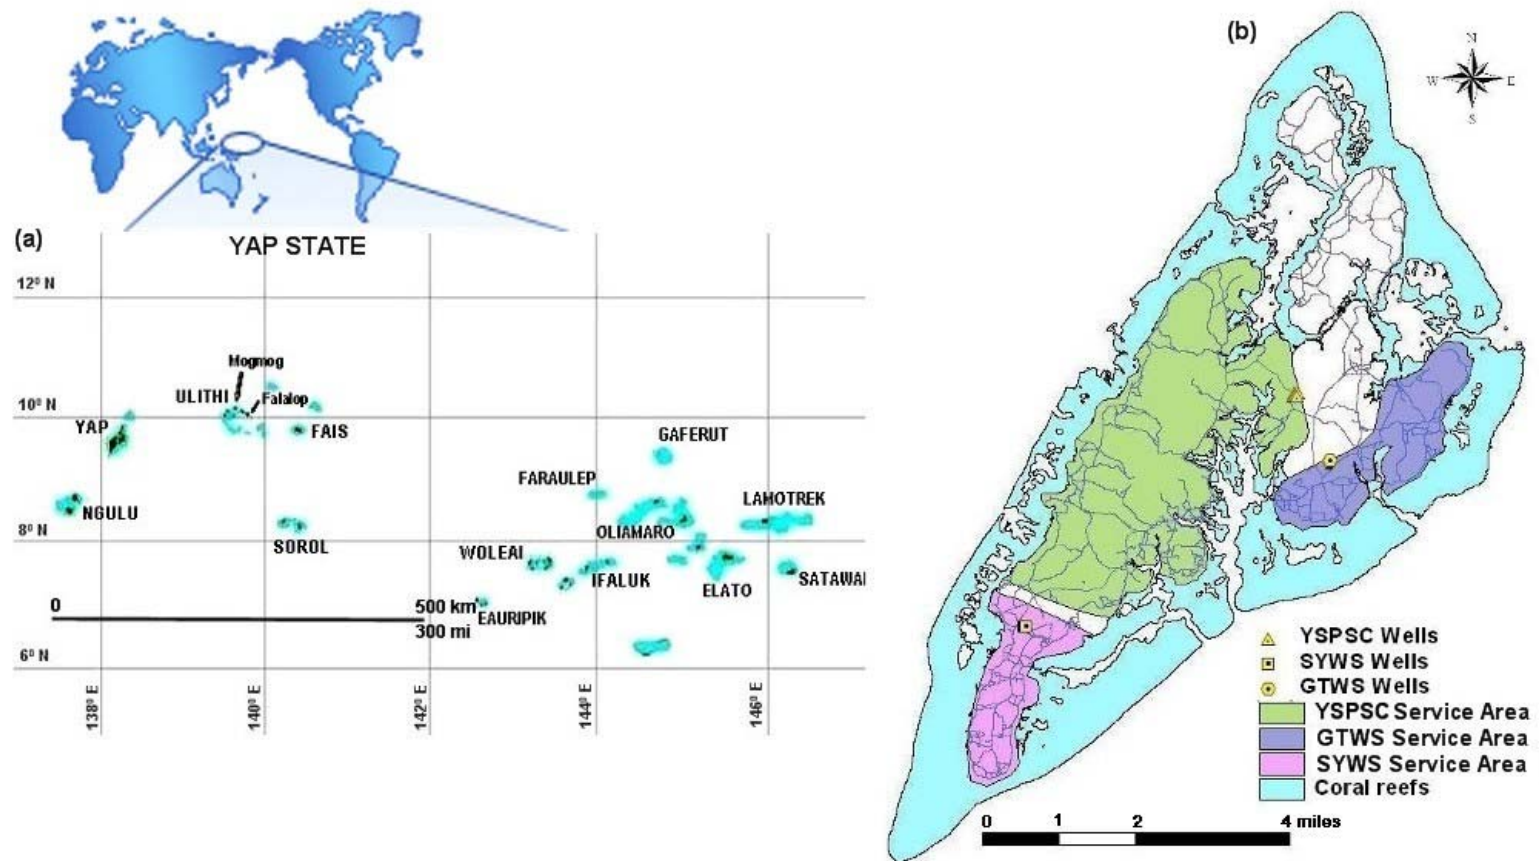
Figure 1 Map showing (a) the location of study site and (b) area of coverage of three large-scale water systems on Yap (also called Yap proper)

This study focused on the three large-scale water supply systems on Yap proper (Figure 1), namely Colonia Water System (YSPSC), Gagil-Tomil Water System (GTWS) and Southern Yap Water System (SYWS), and one lens well at Falalop, Ulithi. While the basic tests, including bacterial tests, have been carried out extensively on samples collected from different localities, detailed analytical tests were conducted primarily on samples collected from five sites – four from Yap proper and one from the neighboring island. Sites were selected based on populations served, the type of source water used, and whether chemical treatments were used. Chemical characteristics and/or contaminants to be tested were selected based on what is commonly found in these types of source waters, as recognized by US EPA.

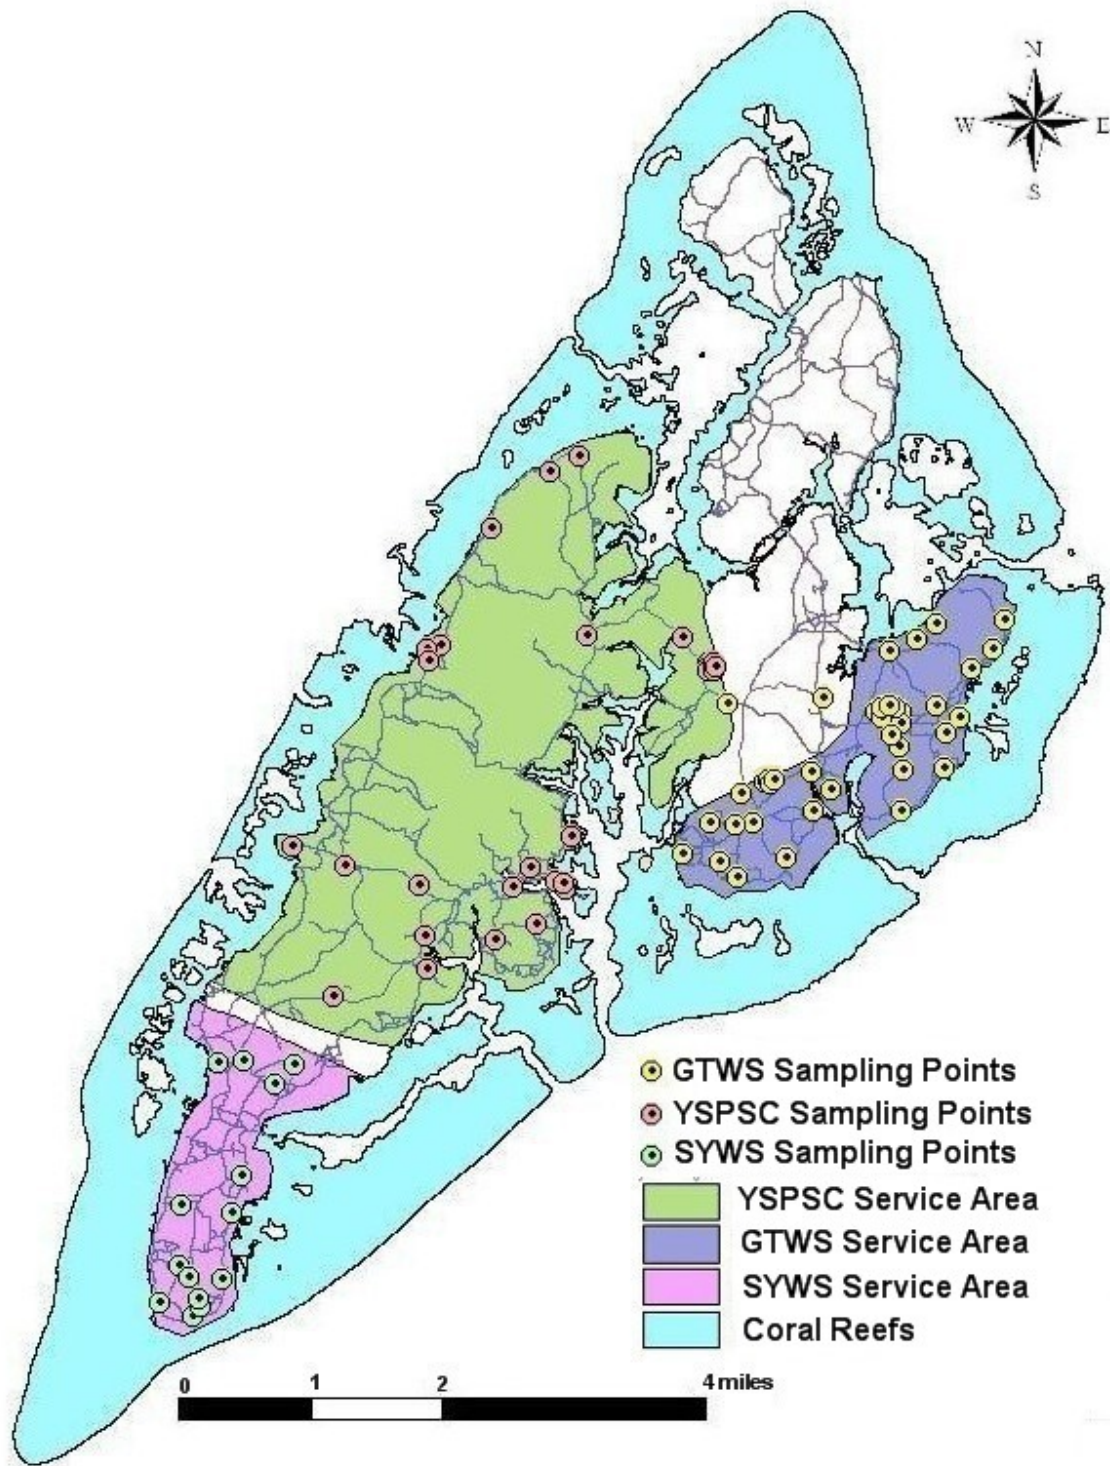
Figure 2 Water sampling locations for bacterial tests on Yap
