LIMITED CURRENT AND BATHYMETRIC SURVEYS AT  
THE MARINE OUTFALL IN LELU HARBOR  
AND  
RECONNAISSANCE SURVEYS OF EFFLUENT DISPOSAL  
SITES AT MALEM AND UTWE, KOSRAE

Technical Report No. 55

Project Completion Report  
for  
Trust Territory of the Pacific Islands  
Contract No. 410046

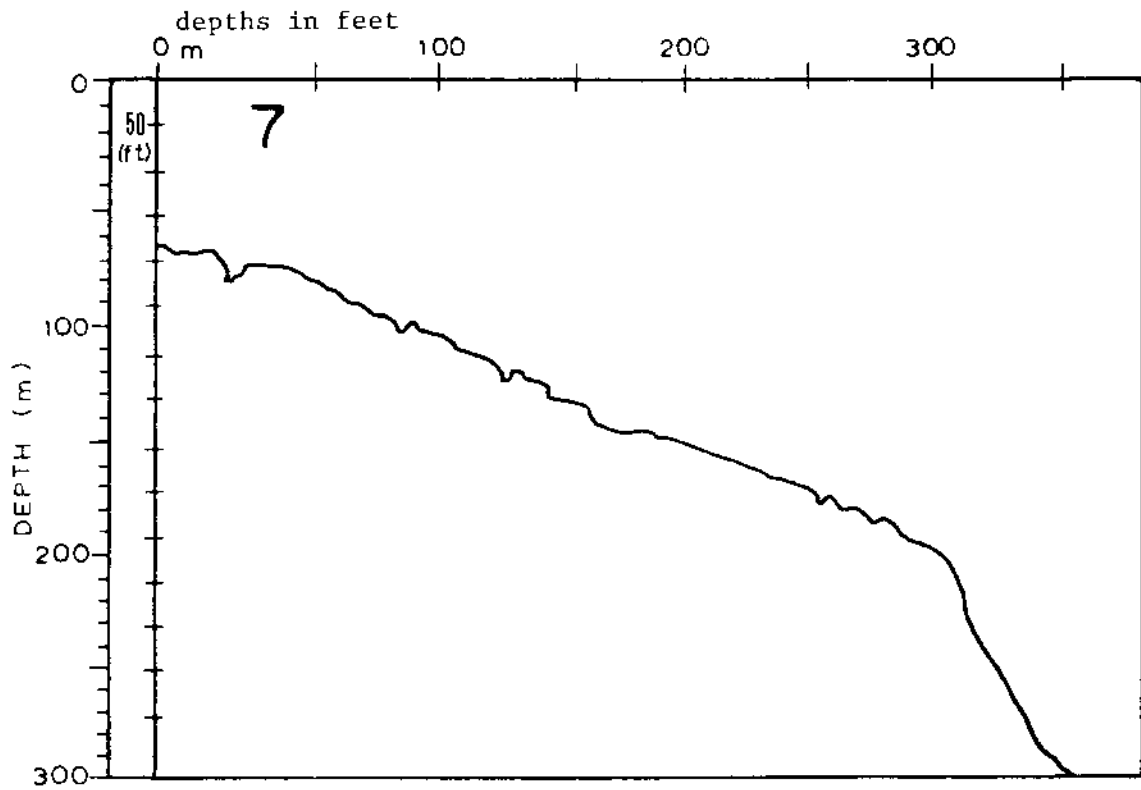
Figure 17. Bathymetric contours of transects 7 and 8. See Figure 14 for location and direction of transects.

In order to better assess the location for a marine outfall in Lelu Harbor, a bathymetric survey was made along selected transects (Figure 14). Fathometer traces were made along transects with emphasis placed on the harbor entrance. A total of 10 transects was made in the harbor. These traces are presented in Figures 15 (traces 1, 2 and 3), 16 (traces 4, 5 and 6), 17 (traces 7 and 8), and 18 (Traces 9 and 10). The harbor is a drowned river valley which has a channel along the northern side (Figure 16). The harbor entrance has steep walls which narrow toward the base (Figure 15: T-30). This restricted entrance greatly influences water flow into and out of the harbor and accounts for the strong flow speeds. The submarine slope seaward of the harbor entrance drops off very rapidly with depths in excess of 300m just 350m east of A bouy (Figure 17: T-7). Depths (in feet and meters) along transects in the harbor entrance and along transect 1 are presented in Table 6. Data from this table were used to contour harbor floor topography at the harbor entrance (Figure 19). This topographic map can be used to help determine placement of a marine outfall.
